Performance Analysis of Repaired High Voltage Insulators

Abstract: This research aims to study the process to repair electric insulator, study the lifetime of the insulators were repaired, and insulator erosion rates were compared within the environment and period of usage by choosing to study especially electrical insulator in high voltage of electricity of Electricity Generating Authority that was removed from the system due to deficiencies in the area of The Electricity Generating Authority of Thailand in Suratthani. By electrical properties and mechanical properties qualifying examination of insulators has been approved. By electrical properties and mechanical properties qualifying testing of insulators has been approved. As the results showed that insulators have been improved by the process of insulators, qualifying values passed the standard test method ASTM A780-01 (2006).

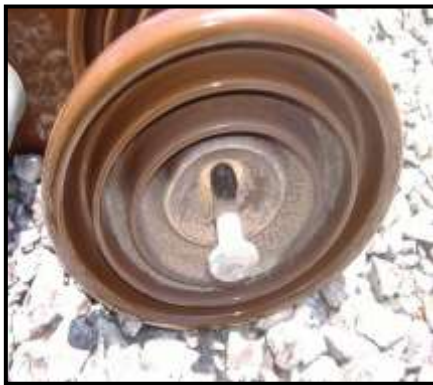
Figure 1. Removed Insulator with rust and corrosion.

This is because the old rusted with pollution in the nature of the rust. Surface contamination Therefore, the surface condition and condition of the insulator rod must be minimized so as to minimize the contamination of the insulated foreign matter and to remove the rust from the core by means of mechanical and electrical methods using the plasma system. In order to be able to carry the cores in a ready state, the coating must be repaired with air, water, humid conditions. Or contaminated with acidity from the environment. This can reduce the corrosion caused by rust and can be stretched to continue using the test period.

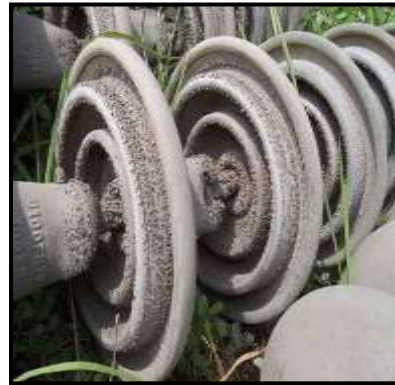
Figure 2. Insulator with cement vapor.

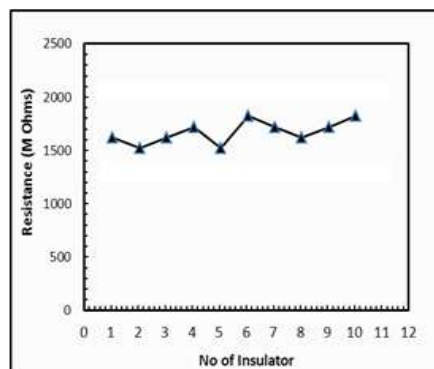
Figure 3. Lightning impulse voltage waveform 1.2/50 μs. **Figure 4.** Dry resistance with various of insulators.

Fig.4. shows measured dry resistance with various of insulators. An amount of insulators are 10 pieces. Fig.5 shows the relation between resistance with insulation age. The insulation age is a long time with low resistance.

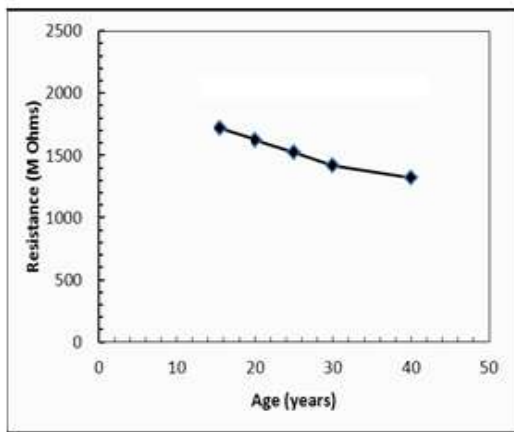
Figure 5. Dry resistance with various of insulators.

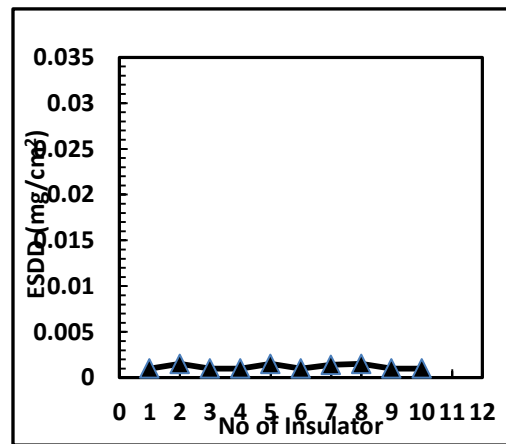
Fig.6 shows measured ESDD values for top surface of selected insulators. All of the values are in accepted region, less than 0.005.

Figure 6. Dry resistance vs Age (Years).

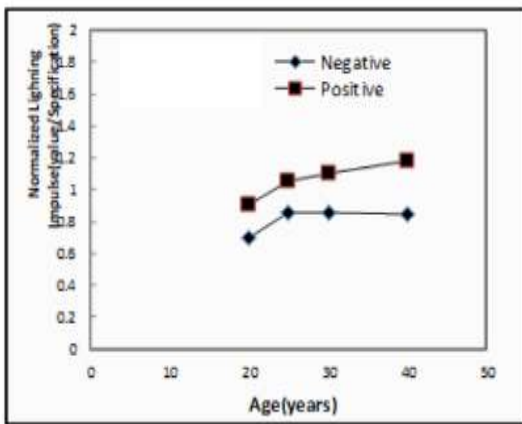
Fig.7 shows positive and negative lightning impulse test results as a function of length of service. All of the values are in accepted region

Figure 7. Positive and Negative Lightning Performance vs Age(Year).

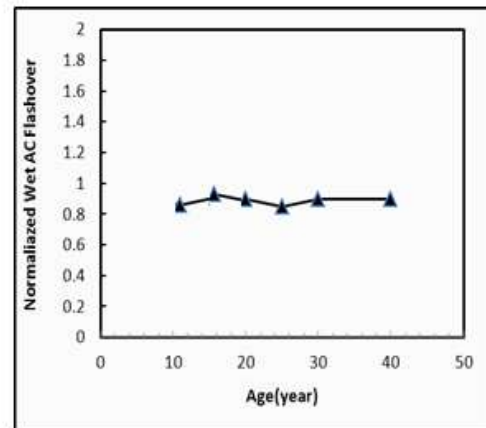
Fig. 8. shows measured AC wet flashover test results. The wet flashover performance of ceramic insulators appears to remain relatively unaffected regardless of service. All of the values are in the accepted region

Figure 8. AC Wet Flashover vs. Age (Years).

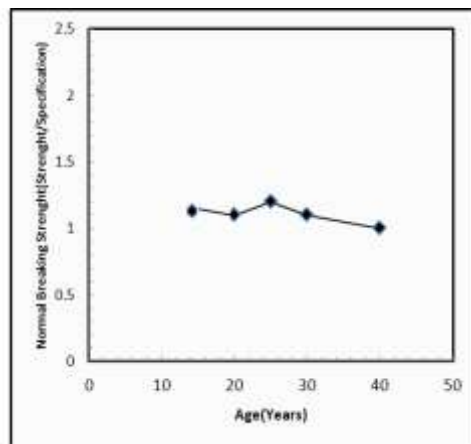
Fig. 9 shows measured mechanical breaking strength of the test pin type ceramic insulators. All of the values are in accepted region

Figure 9. Mechanical Braking Strength vs Age(Years)
