宮崎大学大学院
博士学位論文

**Study on Degradation Diagnostic Technique of
Silicone Rubber**

MAY THIN KHAING

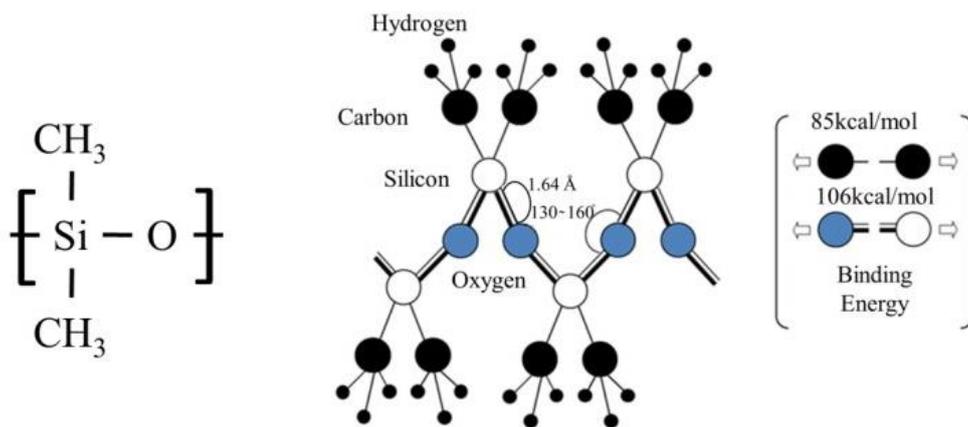
Figure 2.1. Chemical Structure of SiR Bonding Model [42].

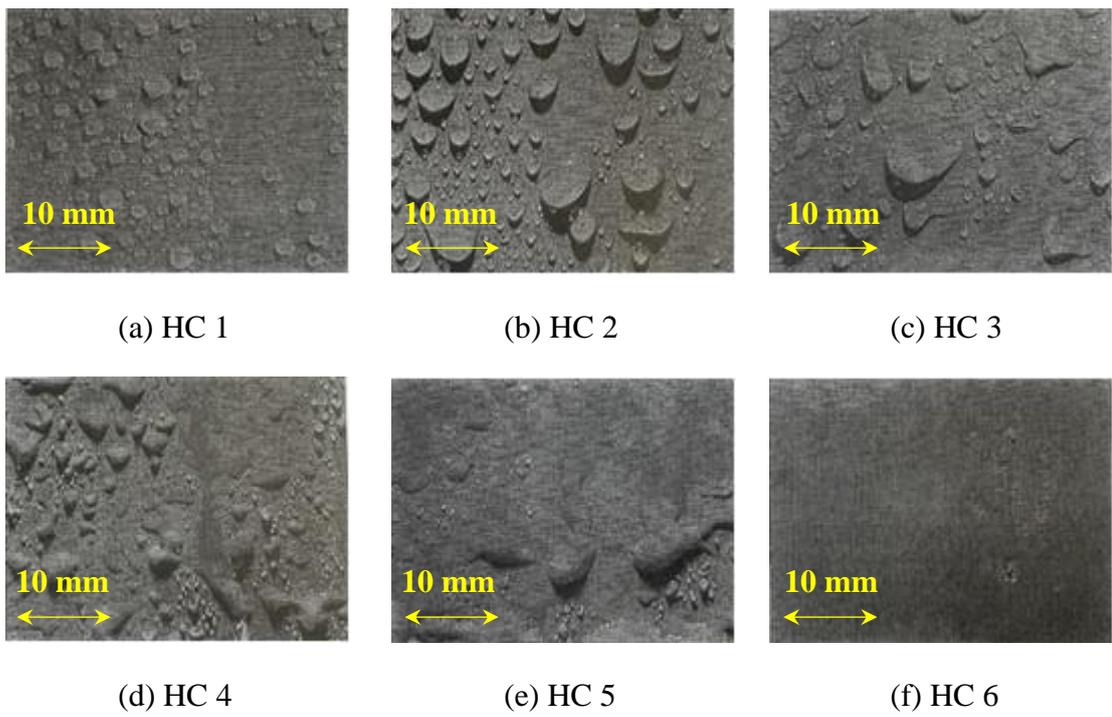
Figure 2.2. Typical Examples of Surfaces with HC from 1 to 6 [43].

HC	Description
1	Only discrete droplets are formed. $\theta_r \approx 80^\circ$ or larger for the majority of droplets.
2	Only discrete droplets are formed. $50^\circ < \theta_r < 80^\circ$ for the majority of droplets.
3	Only discrete droplets are formed. $20^\circ < \theta_r < 50^\circ$ for the majority of droplet. Usually they are no longer circular.
4	Both discrete droplets and wetted traces from the water runnels or water film are observed (i.e. $\theta_r = 0^\circ$). Completely wetted areas $< 2 \text{ cm}^2$. Together they cover $< 90\%$ of the tested area.
5	Some completely wetted areas $> 2 \text{ cm}^2$, which cover $< 90\%$ of the tested area.
6	Wetted areas cover $> 90\%$, i.e. small unwetted areas (spots/traces) are still observed.
7	Continuous water film over the whole tested area.

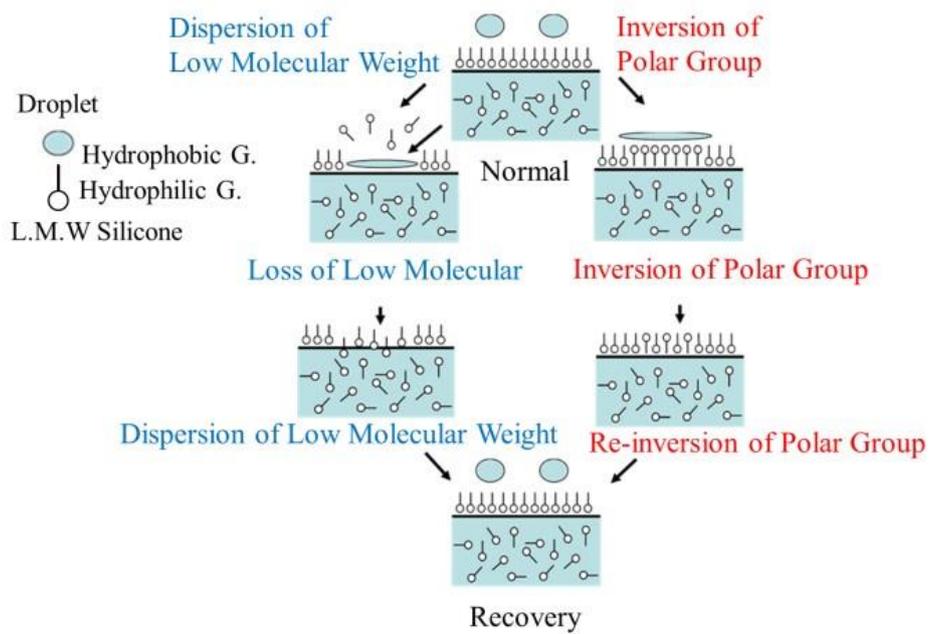
Figure 2.3. Water Repellency Recovery Mechanism.

Figure 2.3 shows the water repellency recovery mechanism by surface dispersion of small molecule components or inversion of polar groups. Regarding the surface water repellency of SiR, the LMW silicone component in the material is uniformly dispersed on the surface to form a hydrophobic surface. If it is characterized by rainfall, the electric discharge occurs. After the electric discharge has occurred, the small molecule component causes losses and decrease the water repellency. However, over a certain period, the water repellency is gradually restored by seeping from the inside of the material to the surface [45]. In particular, regarding the surface dispersion of this small molecule component, it is said that it seeps out to the surface so as to wrap around the wet layer covering the surface. Regarding the time-varying characteristics of this water repellency, it has been pointed out that the siloxane group (polar group) and methyl group (non-polar group) near the surface are inverted. The correlation between the polar group behaviour and the temporal change in water repellency has not been investigated [46].

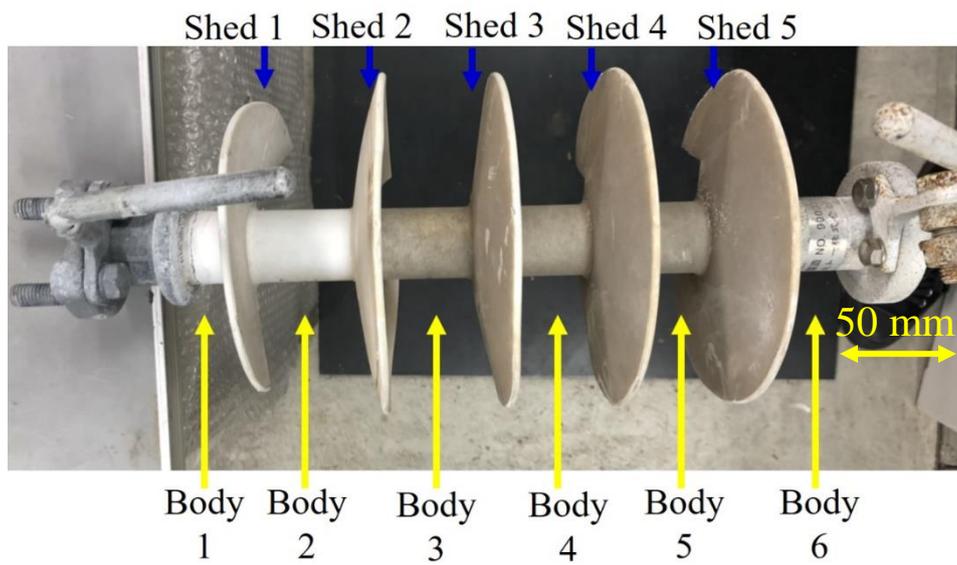
Figure 2.4. Appearance of a 22 kV-SiR Insulator Aged 20 years.

Figure 2.4 shows a 22 kV-SiR-line post insulator arranged in the coastal area with an average yearly temperature of 16 °C and an average annual rainfall of 1600 mm. The creepage distance of the SiR insulator is 650 mm, and the number of sheds with a diameter of 150 mm is 5. SiR contains 50% of alumina trihydrate (ATH). From Figure 2.4, pollution adhesion is recognized. It is noted that Shed 1 and Body 1 were covered with an insulator cover for 20 years in operation. Also, any discharge traces were not visibly recognized on the entire surface. Six specimens cut out from body portions and five specimens from shed portions were prepared, as shown in Figure 2.5. The removal number of aged SiR insulators was one. Because the pollution state and the degradation degree might be dependent on natural stresses at a particular place, a lot of aged specimens are required to grasp the insulation performance of aged SiR insulators. However, this study aims to investigate the characteristics of aged SiR for making artificially degraded SiR surfaces. It will be possible to achieve this purpose by investigating the relationship between the characteristics of polluted surfaces and the electric characteristics. The hydrophobic state on the SiR surface was grasped using a Swedish Transmission Research Institute (STIR) method as explained in Section 2.2.3.1. The contact angle of a water droplet on the SiR surface was measured using a contact angle meter (AUTO 100, Simage) which automatically measured 7 μl of a water droplet dropped from a syringe to each SiR specimen surface. The surface microstructures of aged SiR specimens were observed by scanning electron microscope (SEM). The surface roughness was measured by using a surface roughness tester (DR 130, SATO TECH). The chemical changes were observed using an attenuated total reflection-Fourier transform infrared spectroscopy (ATR-FTIR) (FT/IR-6600ST, JASCO). The variations of Si-O in siloxane bond (1083 cm^{-1}), methyl group Si-CH₃ (1260 cm^{-1}), C-H bond in a methyl group and O-H in ATH intensity ratios of target chemical bonds of aged SiR specimens against those of an unused specimen were evaluated, that is, the peak intensities on an unused specimen are set to reference.

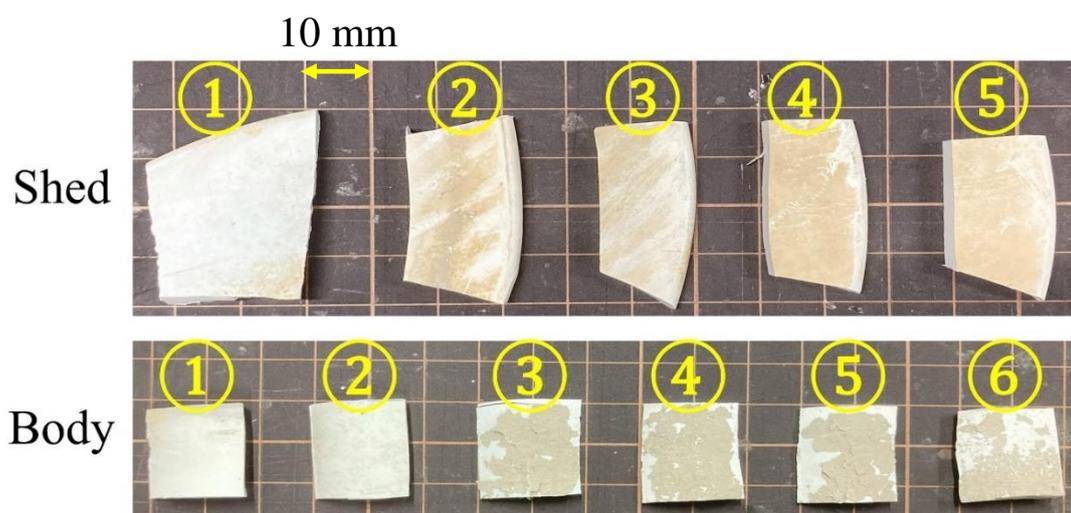
Figure 2.5. SiR Specimens Cut Out from Figure 2.4 (Before Wiping with Alcohol).

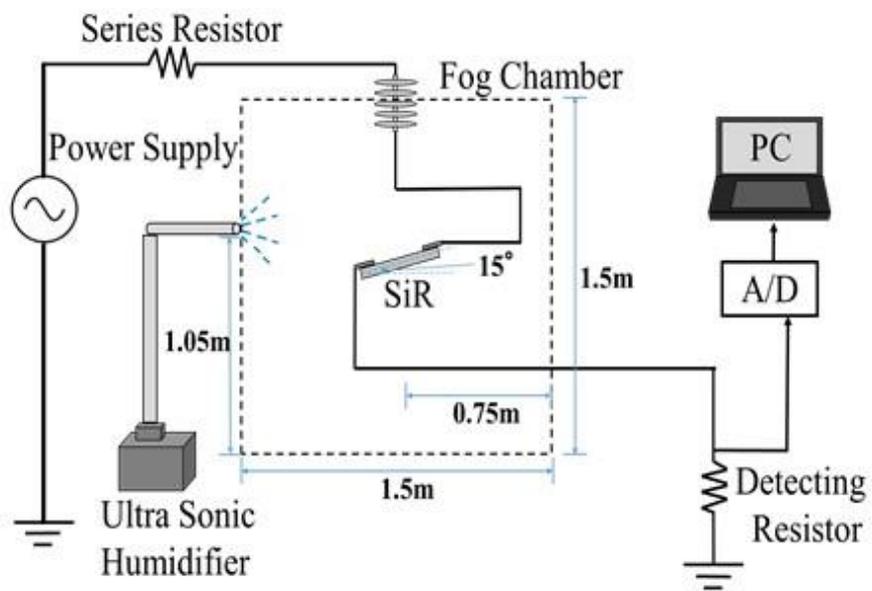
Figure 2.6. Experimental Setup of a 20-times Salt-fog Aging Test.

Therefore, the average electric field is 21.2 V/mm. Because the applied average electric field in the salt fog aging test is 120 V/mm, the voltage stress in the salt fog aging test is 5.7 times larger than that in actual operation. The measurement precision was 0.1 mA. When the leakage current was measured, partial discharges among water droplets occurred as shown in Figure 2.8(b). After that, 72 h was held without applying salt fog and ac voltage. As shown in Figure 2.7, one cycle takes 77 h in total. After each test cycle, the hydrophobicity recovery time was measured.

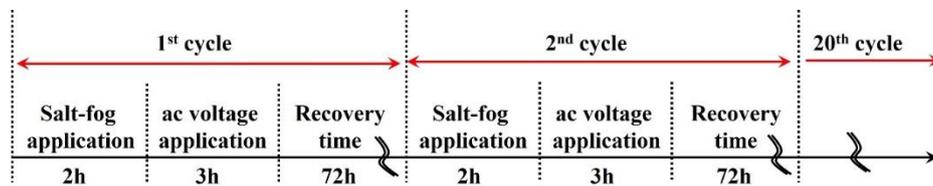
Figure 2.7. Test Cycles for Obtaining Leakage Current and Recovery Characteristics of Hydrophobicity in a 20-times Salt-fog Aging Test.

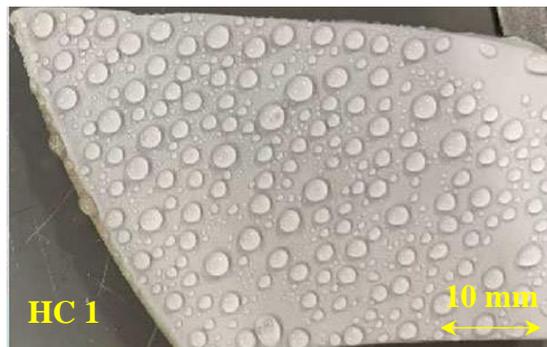
Figure 2.9. Images of a Sprayed SiR Insulator for Investigating Hydrophobicity Class Before/After Wiping with Alcohol (a) Before Wiping and (b) After Wiping.

Figure 2.9 shows example images of a sprayed aged SiR insulator before/after wiping with alcohol. HC on the entire surface of the aged insulator was in the range of HC 1-HC 2 although pollution adhesion was visibly confirmed. To investigate the reason why HC class on the polluted surface still was high, the contact angle of a water droplet on each specimen cut out from the shed or body portion of an aged SiR insulator was measured before/after wiping with alcohol. In the case of measurements of shed portions, the upper surfaces of sheds were measured. The contact angle on an unused SiR specimen was also measured. The results are shown in Figure 2.10. The number on horizontal axis indicates the measured portions shown in Figure 2.4. The contact angles on the upper shed surfaces of Sheds 1, 3, and 5 before wiping are lower than that of an unused specimen. However, by removing foreign matters capable of wiping, the low contact angles become higher than that of an unused specimen. In the case of body portion, although the contact angle of Body 1 is lower than that of an unused specimen, it becomes higher than that of an unused specimen after wiping.

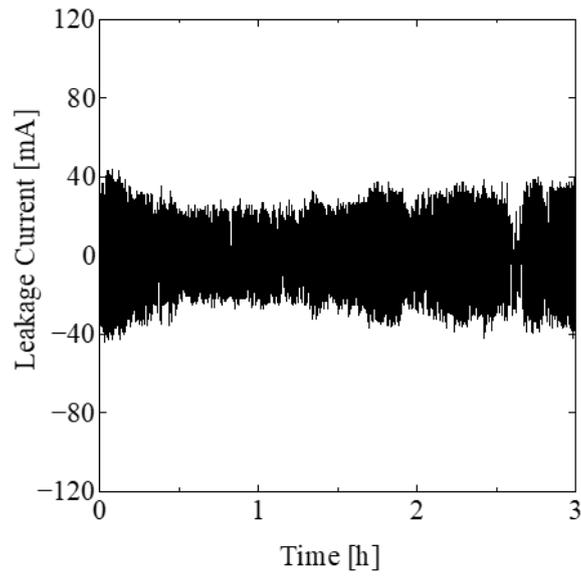
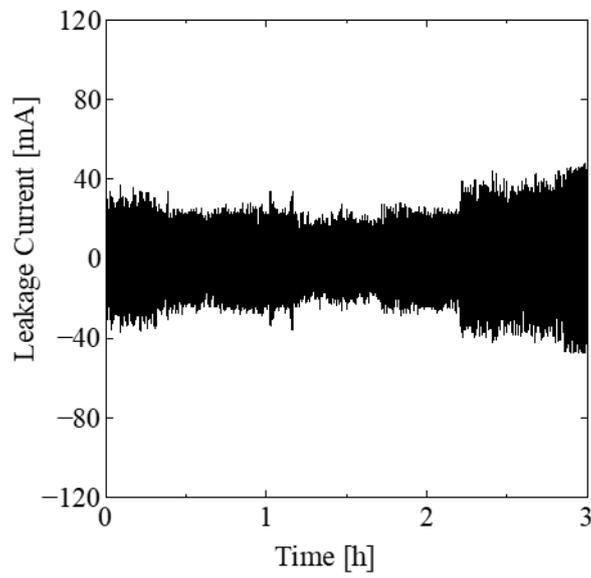
Figure 2.17. Temporal Variations in Leakage Current (a) 1st Cycle and (b) 20th Cycle in a 20-times Salt-fog Aging Test.

A 20-times salt fog aging test was conducted on specimens cut out from Sheds 1 and 5. Considering the actual dry band arcing occurred on the polluted surface, the surfaces of aged SiR specimens were not wiped off in this test. Figure 2.17 shows a typical variation in leakage current obtained at the 1st and 20th cycle in a 20-times salt fog aging test. The leakage current owing to partial discharges among water droplets on the SiR surface was continuously measured. Then, the cumulative charge by integrating the leakage current in each cycle was calculated. Figure 2.18 shows the cumulative charge against the cycle number. The difference in the cumulative charge between an unused, Shed 1 and Shed 5 is not large. As shown in Figure 2.10, foreign matters made the contact angle higher. In each salt fog aging test, the foreign matters capable of wiping might be easily removed by partial discharges generated among water droplets. Further, the partial discharges might make the surface having minute roughness. It is thought that the difference in the cumulative charge did not become large because there is no large difference in the surface states between the surface influenced by the partial discharges and the unused surface.

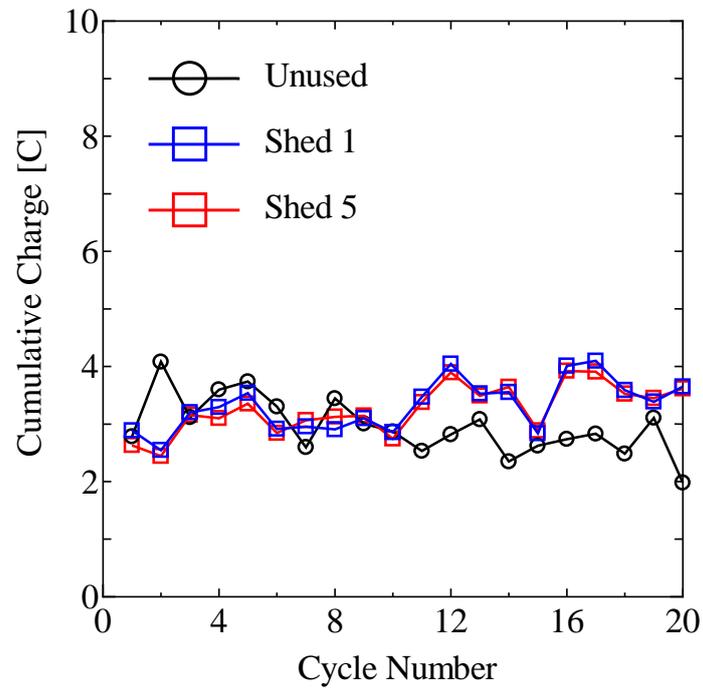
Figure 2.18. Cumulative Charge in Each Cycle.

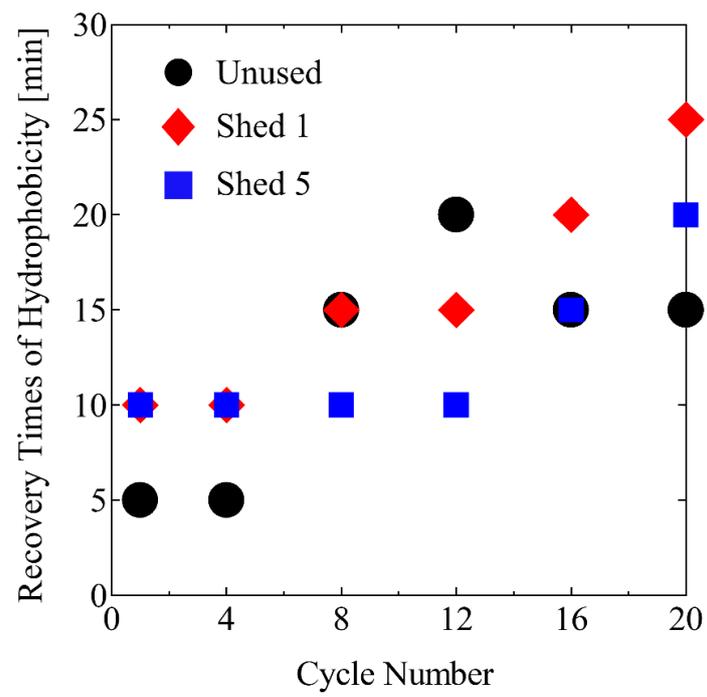
Figure 2.20. Hydrophobicity Recovery Times of Aged Shed Specimen and Unused SiR specimen.

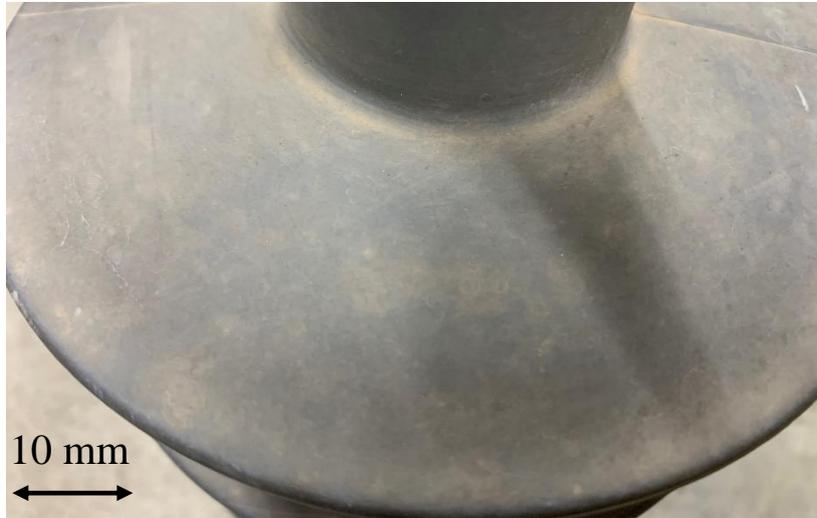
Figure 3.1. Appearance of 22 kV-SiR Insulators (a) Aged 10 Years and (b) Aged 20 Years.

Aged insulators arranged for 10 and 20 years on distribution lines were used. Figure 3.1 shows 22kV-SiR-line post insulators arranged in coastal areas with an average yearly temperature of 18°C and an average annual rainfall of 2300 mm. The creepage distance of the SiR insulator is 950 mm, and the number of sheds with a diameter of 150 mm is 7. SiR contains 50% of ATH. From Figure 3.1, pollution adhesion is recognized. However, any discharge traces weren't recognized on the entire surface. The features of actually aged SiR insulators were compared with that of unused SiR. The removal numbers of aged SiR insulators were 2. Because the pollution state and the degradation degree might be dependent on natural stresses at a particular place. However, the aim of this study is to make the artificial degradation surface, i.e., to artificially reproduce the degradation surface whose characteristics are similar to those of a SiR insulator aged in outdoor.

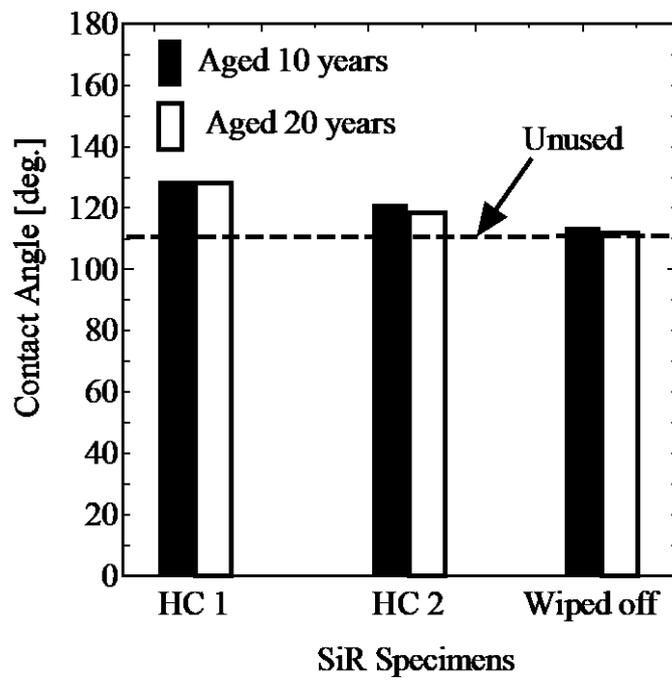
Figure 3.3. Contact Angles on Unused and Aged SiR Specimens.

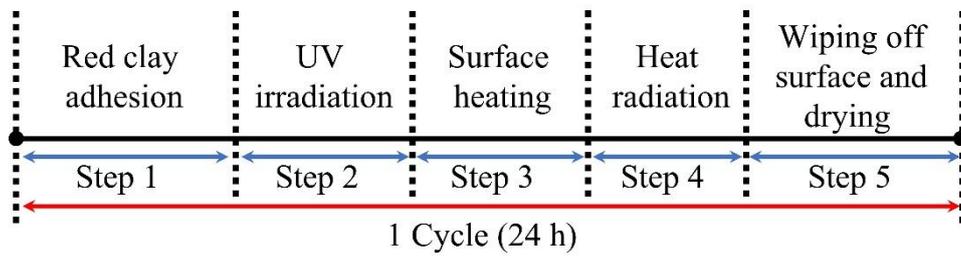
Figure 3.6. A Cycle Consisting of Red Clay Adhesion, UV Ray Irradiation and Surface Heating for Artificially Making Degraded Surface.

By the way, the appropriate time of UV irradiation (Step 2) was unknown. Therefore, to investigate the effect of UV rays on the degradation of the SiR surface, UV irradiation with irradiation times of 2 h, 4 h, 6 h, or 8 h was performed against each specimen as shown in Table 3.1. Apart from that, heating at temperatures (T) of 20°C, 40°C, 60°C or 80°C for 4 h was carried out as shown in Table 3.2 because the appropriate heating temperature was unknown. The heating duration of 4 h was determined from the result of the appropriate UV irradiation time, which coincided with the one-cycle duration time of 24 h.

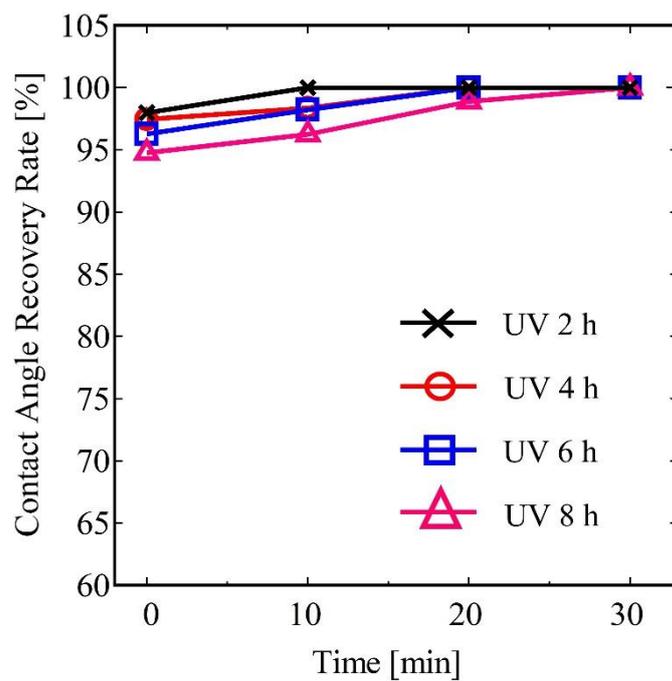
Figure 3.7. Contact Angle Recovery Rates under Various UV Irradiation Times without Step 3.

The average contact angle of a water droplet on the SiR surface before UV irradiation was 102.8°. After each experiment, the cleaning by using a writing brush and ionized water couldn't remove visible substances adhering to the SiR surface. This indicates that UV irradiation makes red clay adhesion stronger. Following cleaning by using a writing brush and ionized water for 3 min, cleaning by using alcohol and disposable wipers was performed for 3 min. The visible red clay was removed by this work. The averaged contact angles measured after removing visible red clay in the cases of UV2h, UV4h, UV6h, and UV8h were 101.07°, 100.1°, 98.07°, and 97.4°, respectively. They are smaller than the initial value. Due to UV irradiation, the molecular structure of SiR is broken and its contact angle decreases. The contact angle recovery rates against an initial value in 5 cases are shown in Figure 3.7. The contact angles recover to an initial value within 30 min. LMW components disperse in SiR and it makes a new containment layer on the surface of SiR. From the viewpoint of making the degraded surface in a short time, it is desirable that the new containment layer is formed in a short time. The UV irradiation for 8 h largely decreased the contact angle. However, the recovery time was the longest. Then, the appropriate time of UV irradiation was set at 6 h in this study.

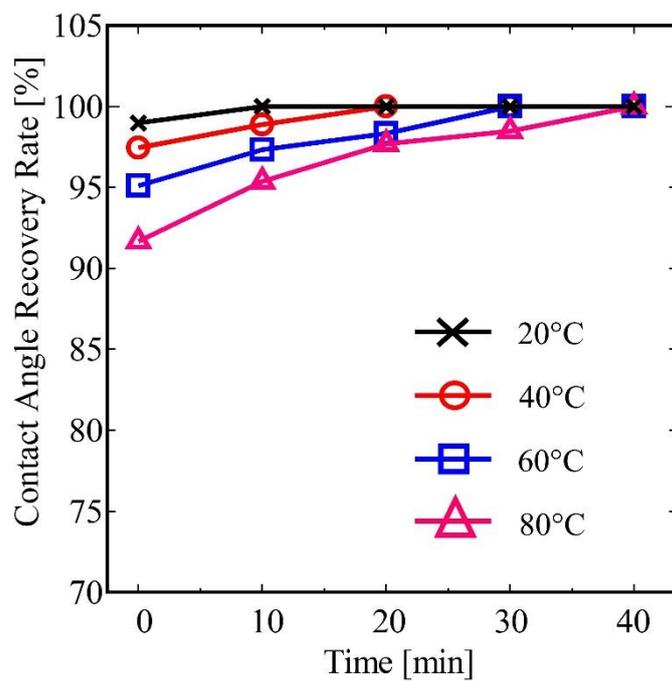
Figure 3.8. Contact Angle Recovery Rates under Various Heating Temperatures without Step 2.

The required recovery time at 40°C is 20 min and it is the same as that in the case of UV4h. The surface free energy of the SiR surface is reflected in the hydrophobic character. Due to surface heating, LMW fluid from the bulk to the surface is promoted and an LMW-enriched surface is formed. As a result, the surface free energy on the LMW surface becomes larger and then the contact angle becomes smaller [49]. Therefore, the contact angle after surface heating decreases from the initial value. After that, the surface free energy becomes smaller due to the volatilization of LMW siloxane with the lapse of time [50], which restores the contact angle to an initial contact angle. Thus, although the surface heating over 40°C can make the contact angle smaller, the red clay on the surface is easily removed and the contact angle recovers to an initial value in a short time, i.e., the surface heating process is not enough to artificially make the degraded surface which has similar characteristics to the degraded surface in outdoor. Therefore, it was considered that a combination of UV irradiation for breaking molecular structure and surface heating for promoting LMW dispersion can make the artificially degraded SiR surface in a short time.

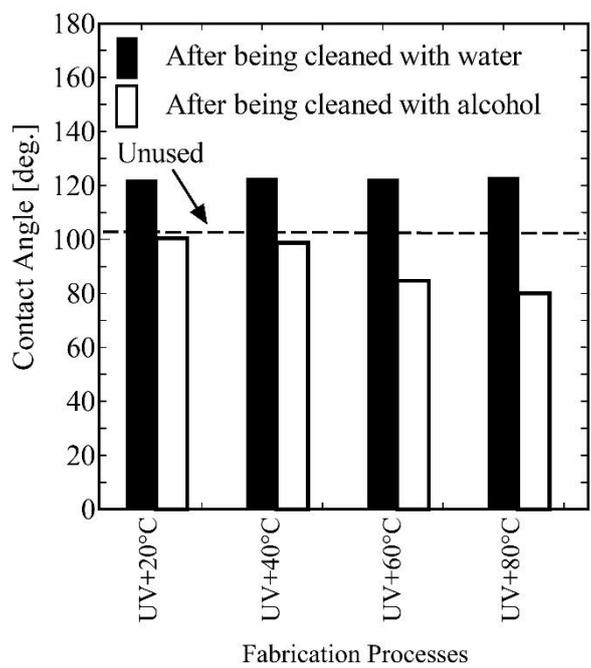
Figure 3.10. Comparison of Contact Angles of Fabricated SiR Surface after Wiping off with Ionized Water and Alcohol.

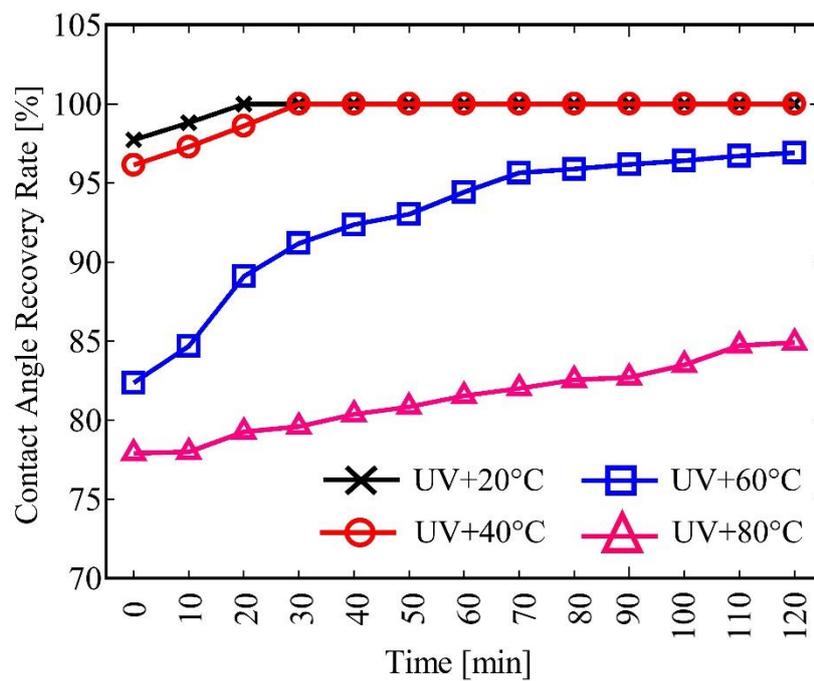
Figure 3.11. Contact Angle Recovery Rates on SiR Surfaces Fabricated with UV Ray Irradiation and Surface Heating.

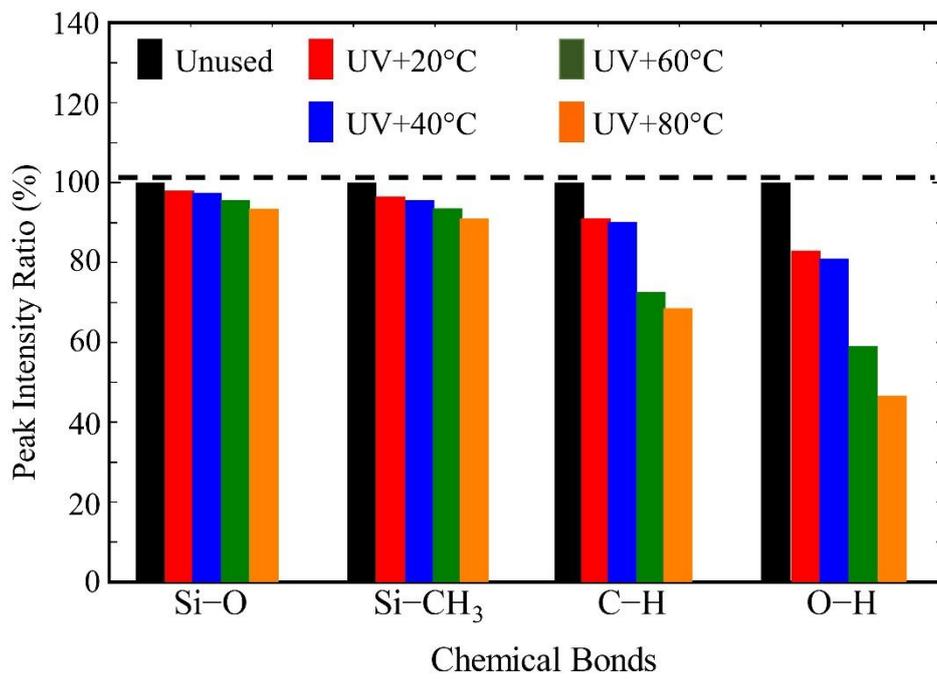
Figure 3.12. Peak Intensity Ratios of Targeted Chemical Bonds of Fabricated SiR Surface.

Figure 3.12 shows the ATR-FTIR peak intensity ratios of fabricated SiR surface, in which peak intensities on an untreated SiR surface are set to reference. The peak intensity ratios corresponding to Si-O, Si-CH₃, C-H, and O-H bonds of fabricated SiR surfaces are smaller than those of an untreated specimen. Especially, C-H bonds significantly decrease at $T = 60^{\circ}\text{C}$ and 80°C . Due to UV irradiation and surface heating, the molecular structure of SiR can be damaged. Not only the ATH structure but also the side chains as C-H and Si-CH₃ are broken, and then free radicals such as H• and CH₃ are formed [18][47]. At the same time, surface heating can split the Si-O-Si group into free radicals of Si-O and Si [51]. Therefore, the cross-linking reactions change the original SiR surface into the degraded surface. Under this surface state, red clay is easily introduced into SiR through LMW dispersion promoted by surface heating. Finally, by comparing the results shown in Figures 3.5 and 3.12, it is found that the peak intensity ratios obtained in the cases of UV+20°C and UV+40°C are similar to those on a specimen aged 10 years with HC 2.

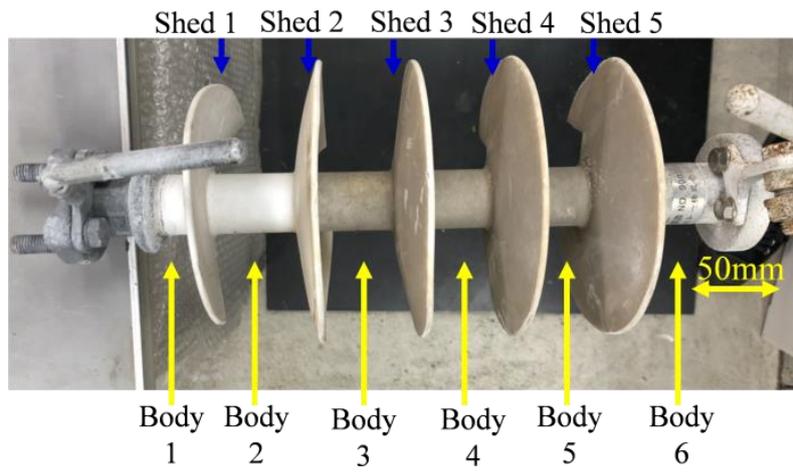
Figure 4.1. 20 Years Aged SiR Insulator Used in Actual System.

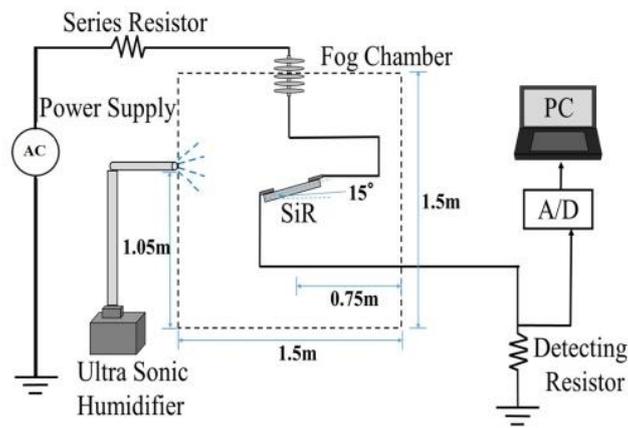
Figure 4.3. Experimental Setup of Salt-fog Aging Test.

In the experiment, the salt fog aging test was repeatedly performed until 20th cycle as shown in Figure 4.4. Firstly, a hydrophobicity level is identified as HC1 by using a STRI method. HC1 is preferred as the condition that the discrete droplets are only formed. After that, the leakage current and hydrophobicity recovery time were measured in each cycle. Then, the leakage current and hydrophobicity recovery time of a 20 years aged specimen were compared with those of an unused specimen. Finally, a good index was mentioned for degradation monitoring of the actual aging polymeric insulator.

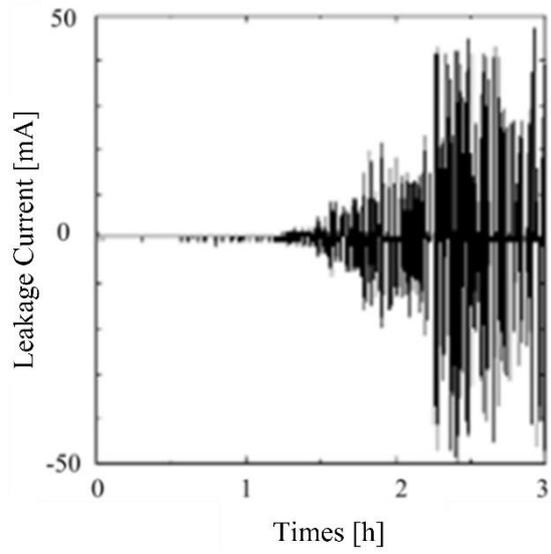
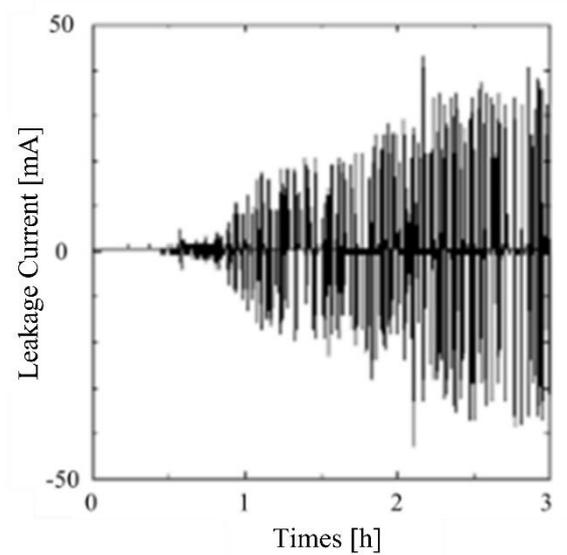
Figure 4.8. Leakage Current of an Unused Specimen.

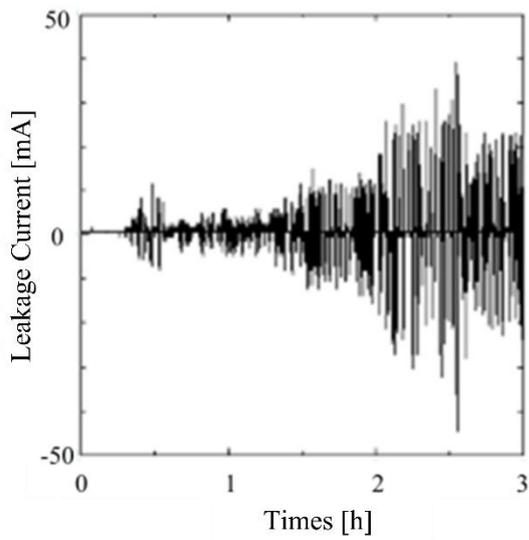
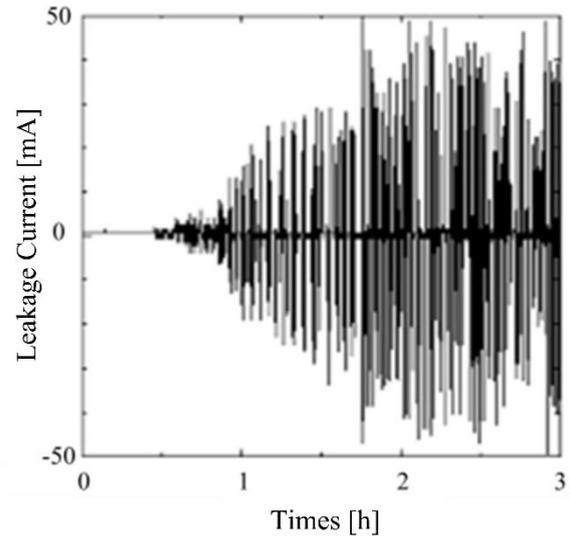
Figure 4.9. Leakage Current of 20 Years Aged Specimen.

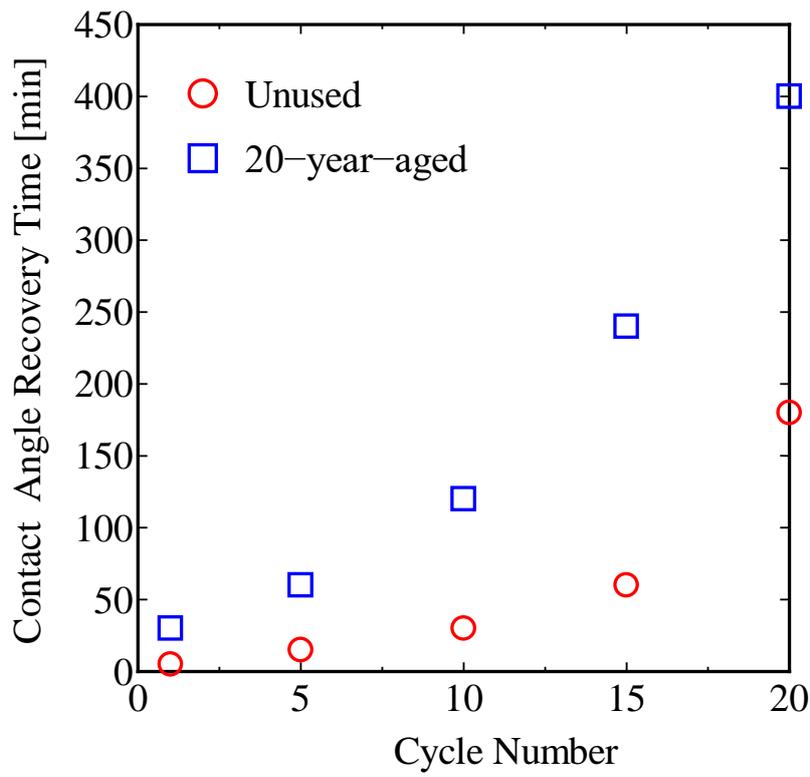
Figure 4.10. Difference of Hydrophobicity Recovery Time between 20 Years Aged Specimen and an Unused Specimen.

Figure 4.10 shows the required time for hydrophobicity recovery in minutes of an unused specimen and 20 years aged specimen. In Figure 4.10, the blue rectangular shape is represented by hydrophobicity recovery time of 20 years aged specimen and the red circle shape is represented by the hydrophobicity recovery time of an unused specimen. It is clearly seen that the hydrophobicity recovery time of 20 years aged specimen is significantly longer than that of an unused specimen.

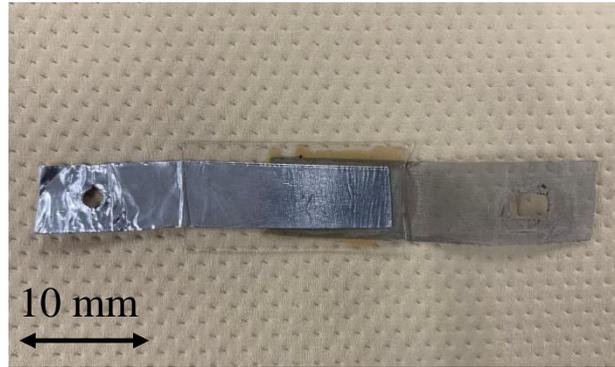
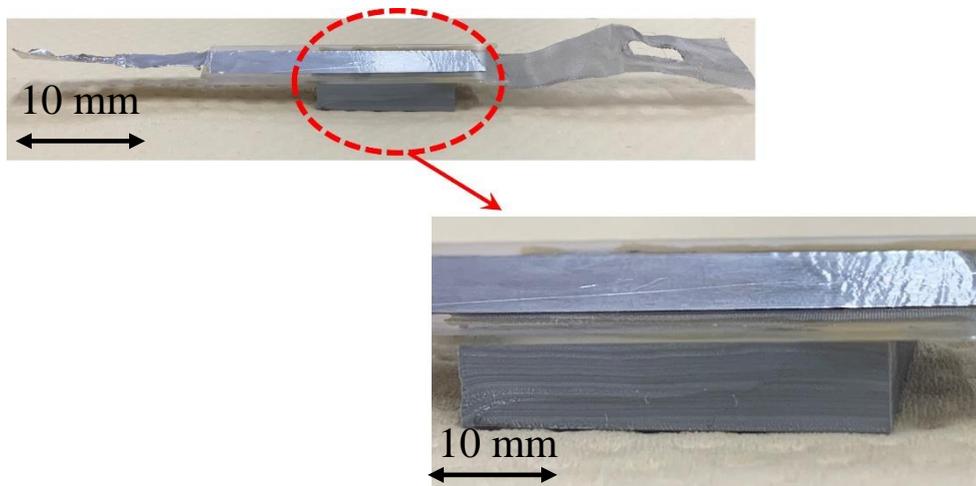
Figure 4.11. Electrode Configuration for Generating SD.

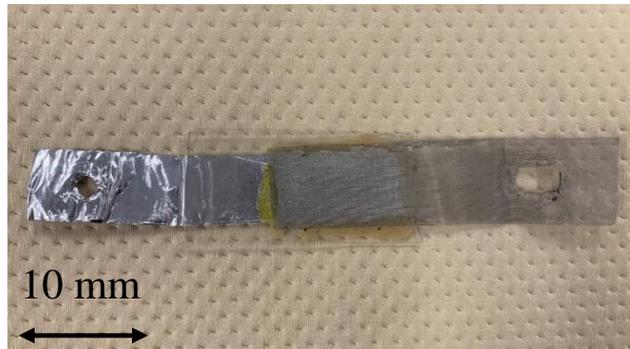
(b) Top View (From Mesh Plate)

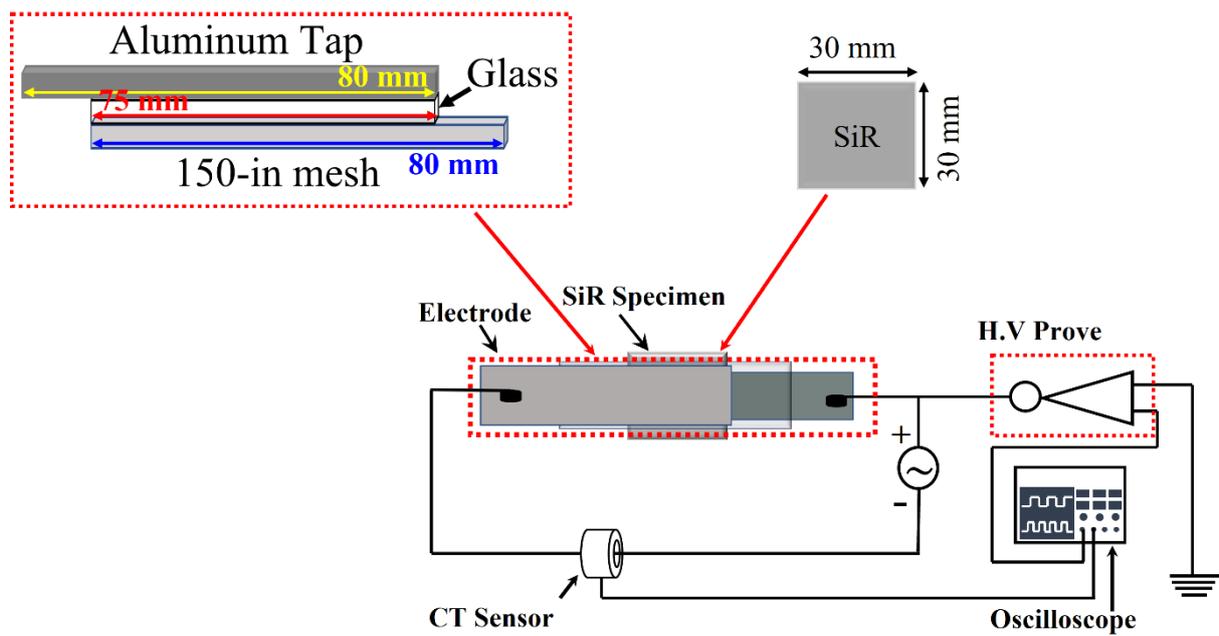
Figure 4.12. Schematic Diagram of an Experimental Setup for SD Treatment.

experimental setup for SD treatment is shown in Figure 4.12. The surface treatment time was set at 5, 10, 15, 20 and 25 s. The recovery characteristics of hydrophobicity on SiR specimens were evaluated by measuring the contact angle of a water droplet on the SiR surface. After each SD treatment, 7 μ L of a water droplet was dropped from a syringe to the SiR surface. The contact angle of the water droplet was measured by using a contact angle meter which was automatically measured. Additionally, SEM and ATR-FTIR measurements were performed whether physical or chemical damages were caused by a SD treatment, or not.

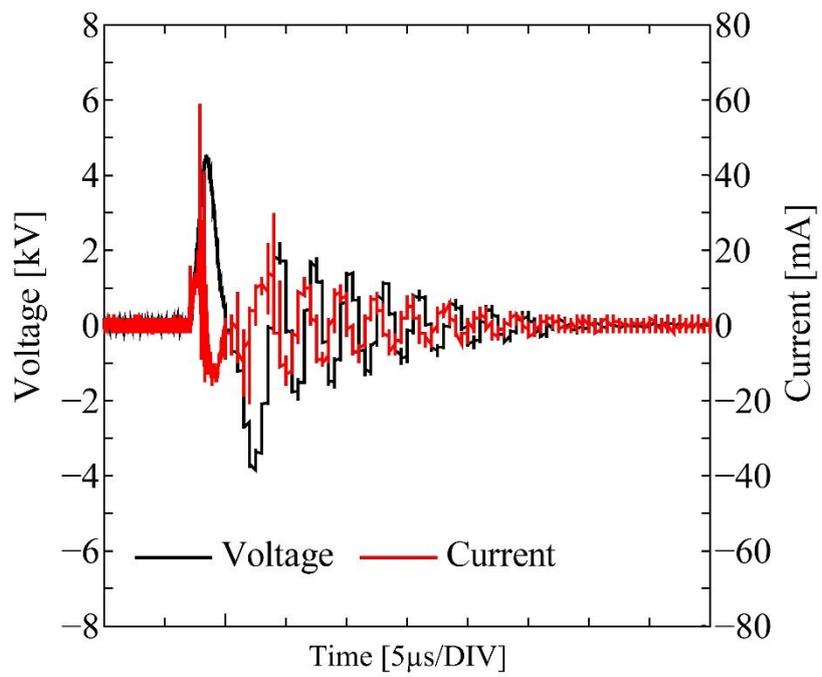
Figure 4.13. Waveforms of Applied Voltage and Discharge Current in an SD Treatment.

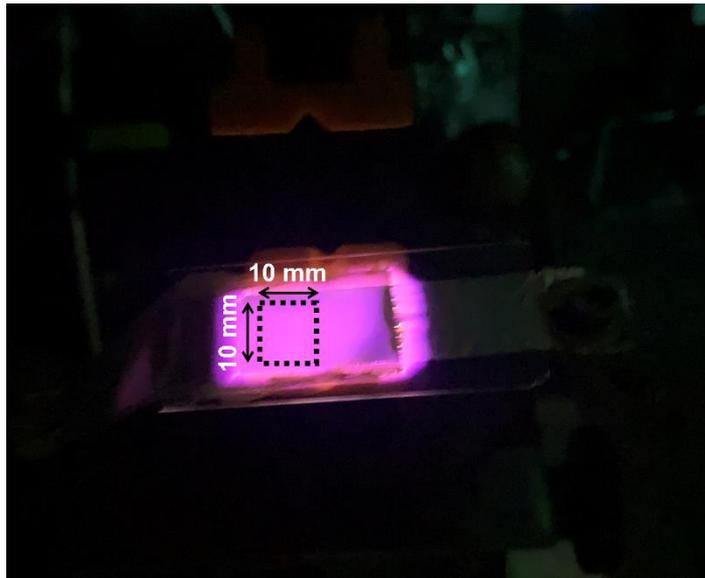
Figure 4.14. Appearance of Uniformly Formed SD on a 150-mesh Plate.

In Figure 4.14, SD is uniformly generated on a 150-mesh plate. As mentioned above, the size of an overlapped area between an Al tape and a 150-mesh plate on a glass plate was 20 mm by 30 mm. To uniformly treat the SiR surface, the center area of the SiR surface with $20 \times 20 \text{ mm}^2$ was arranged on the SD area with $10 \times 10 \text{ mm}^2$ indicated by a dotted black line.

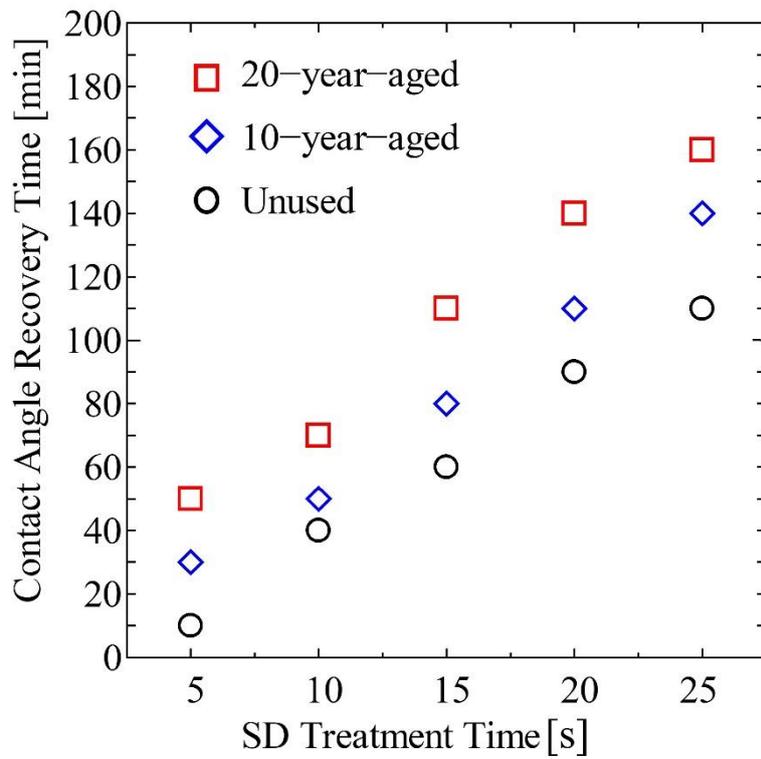
Figure 4.18. Contact Angle Recovery Times on Unused, 10- and 20-year-aged SiR Specimens.

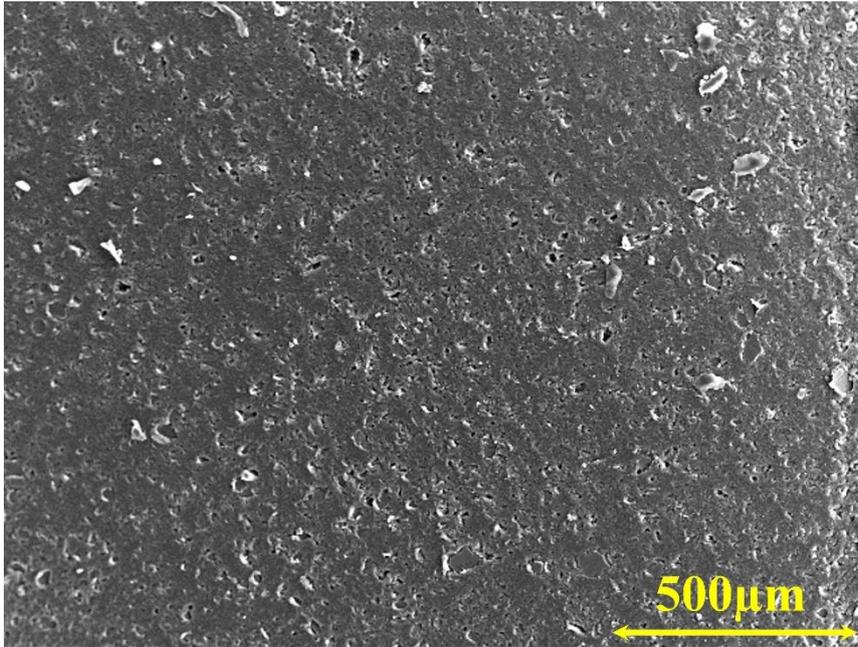
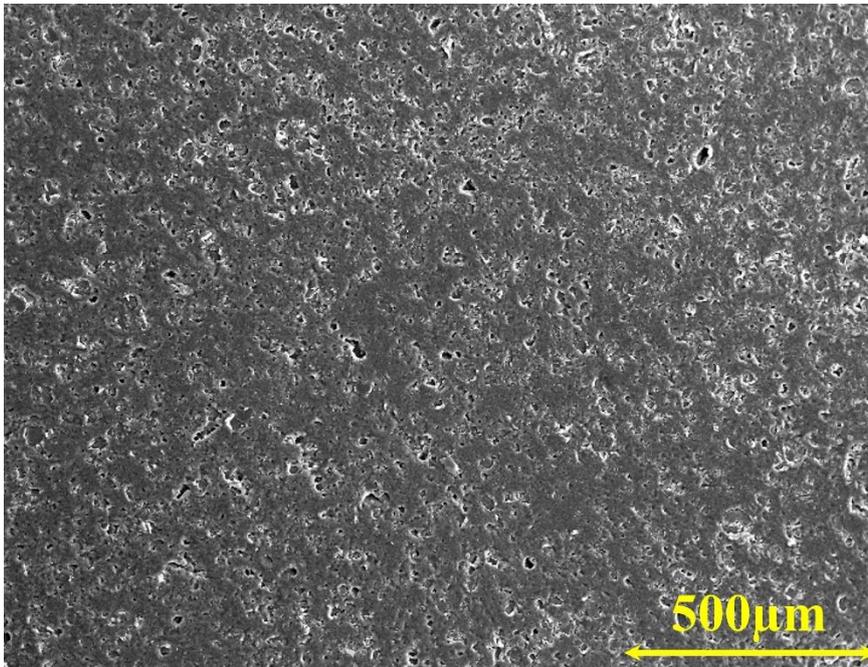
Figure 4.19. SEM Images of an Unused SiR Specimen (a) Before an SD Treatment and (b) After an SD Treatment for 25 s.

In order to observe the treated SiR surface, SEM image evaluation was performed. SEM images on an unused SiR specimen before and after an SD treatment for 25 s are represented in Figure 4.19. The obvious cracks or other physical damages cannot be seen after the SD treatment. Next, the ATR-FTIR spectra of an unused SiR specimen were measured to analyse chemical damages. Figure 4.20 shows the ATR-FTIR spectra of an unused SiR specimen before and after the SD treatment for 25 s. The obvious spectral changes in the spectra before and after the SD treatment cannot be seen. Additionally, the peak intensity ratios of chemical bonds such as Si-O, Si-CH₃, C-H and O-H in ATH before and after the SD treatment were evaluated, and the result is shown in Figure 4.21. The ratios of Si-O, Si-CH₃, and C-H after the SD treatment slightly decrease in comparison to those before the SD treatment, however, the difference is less. It is considered that the SD treatment doesn't cause physical or chemical damage to the surface of the SiR specimen.

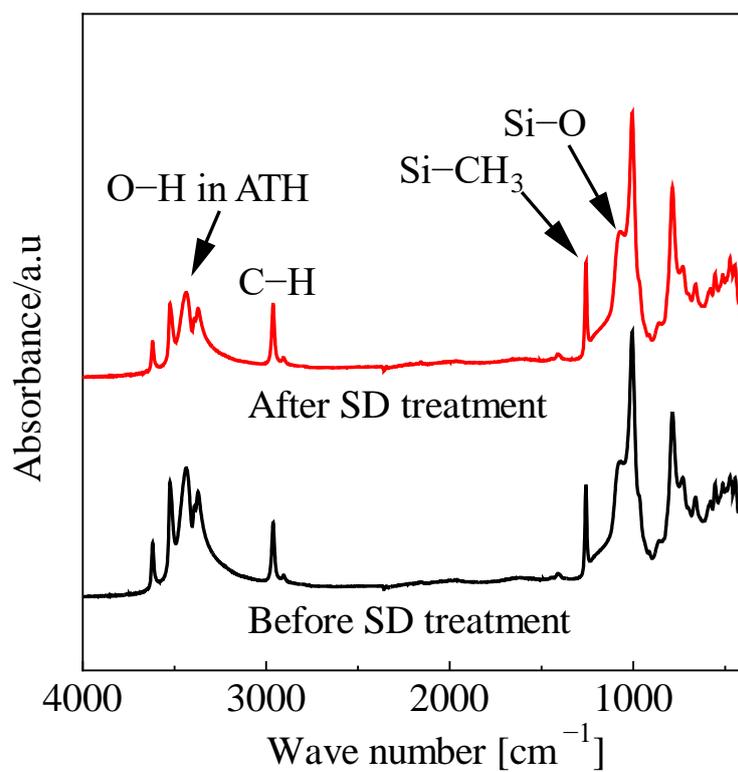
Figure 4.20. ATR-FTIR Spectra of an Unused SiR Specimen before and after an SD Treatment for 25 s.

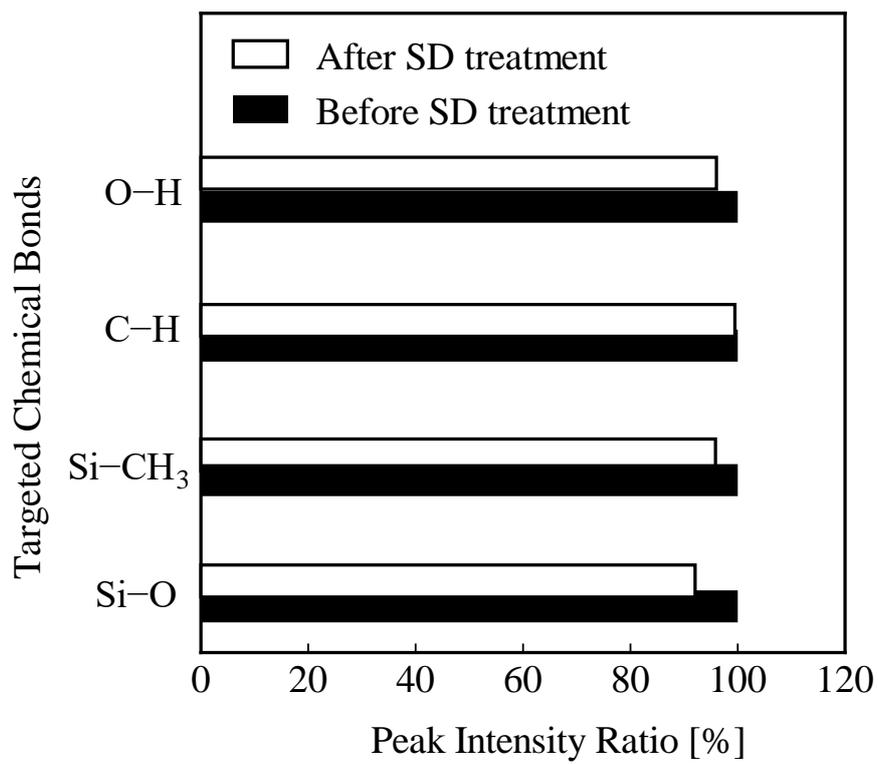
Figure 4.21. Peak Intensity Ratio of Chemical Bond of an Unused SiR Specimen before and after an SD Treatment for 25 s.
