宮崎大学大学院
博士学位論文

**Study on Degradation Diagnostic Technique of
Silicone Rubber**

MAY THIN KHAING

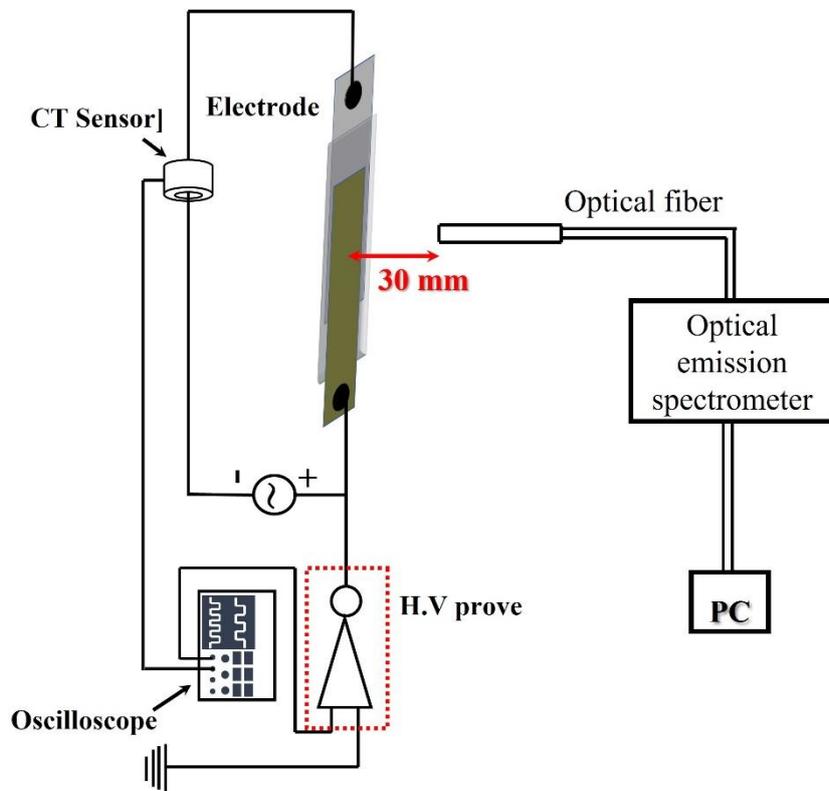
Figure 4.22. Experimental Setup.

A schematic diagram of an experimental setup is shown in Figure 4.22. An H.V. probe was connected to a mesh plate for applying voltage while an Al tape was earthed. An HFCT sensor was used to measure the SD current. The applied voltage and the SD current were recorded by a digital oscilloscope with a sampling frequency of 1.25 GHz. In the experiments, 8 kV with the high frequency of 10 kHz was applied and the applied SD treatment time was set from 5 s to 25 s. The SD current was analyzed by fast Fourier transform (FFT) and applied a high pass filter (HPF). To investigate the reason why the SDs cause the hydrophobicity loss, the surface temperature on the mesh plate during an SD treatment was measured by using an infrared thermography camera (FLIR C3, FLIR Systems AB). In addition, to observe the optical emission spectra, a fiber optical spectrometer (USB4000, Ocean Optic) was faced about 30 mm from the surface of an SD electrode.

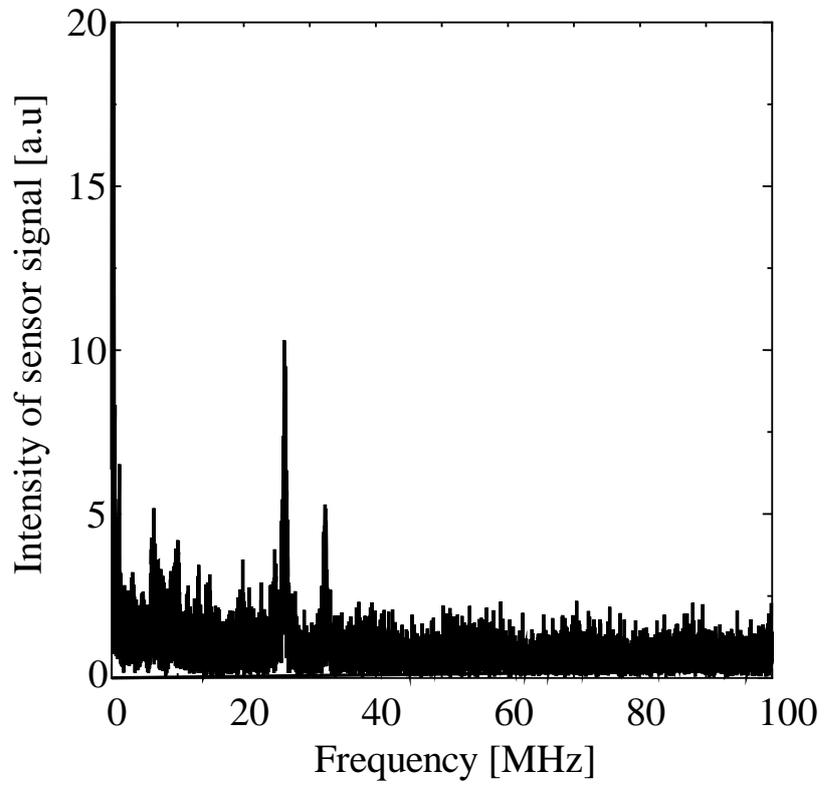
Figure 4.23. Frequency Spectra of SD Current Obtained through FFT Analysis.

On the other hand, the displacement current due to the capacitance component of an SD electrode system is included in the detected current. Therefore, the discharge current was analyzed with FFT. Figure 4.23 shows the frequency spectra of discharge current obtained by FFT. The main frequency components are 25 MHz and 30 MHz. Because the frequency of applied voltage is 10 kHz, the frequency components of 25 MHz (40 ns) and 30 MHz (33.3 ns) are due to SDs. Based on the result, we applied an HPF of 10 MHz to the detected SD current. The filtered waveform is shown in Figure 4.24. Pulsive current is clearly seen, and therefore it is considered that the SDs consist of filamentary discharges. Figure 4.25 shows uniformly generated SD on the 150-mesh plate of an SD electrode. The image was taken by a digital camera, and the exposure time was much longer in comparison with the detected current pulse duration, i.e., the observed image is the integrated SDs which consist of a lot of filamentary discharges.

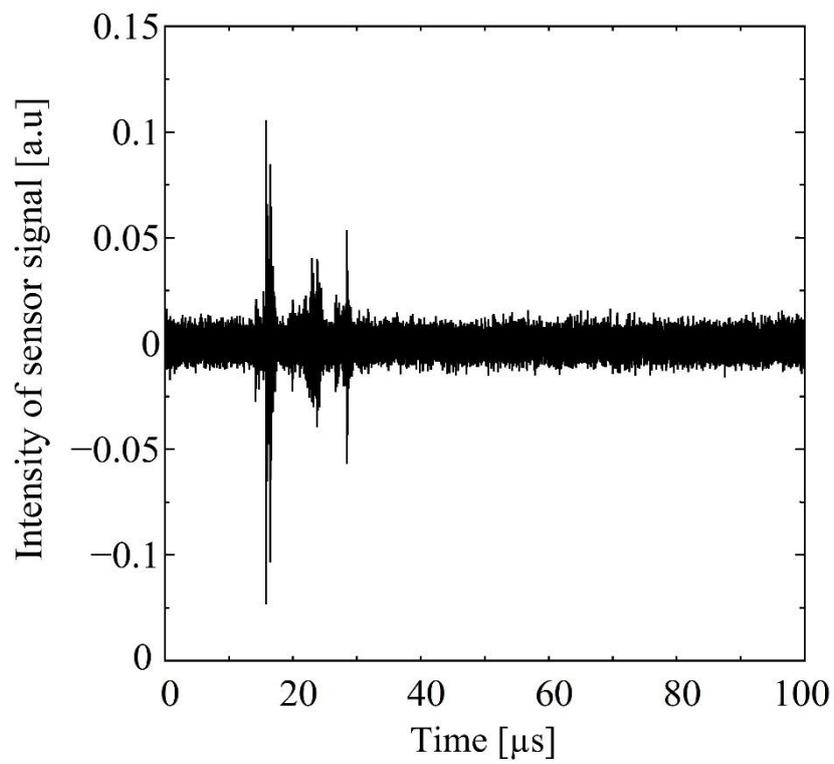
Figure 4.24. Waveform due to Filamentary Discharge Obtained through a 10 MHz-HPF.

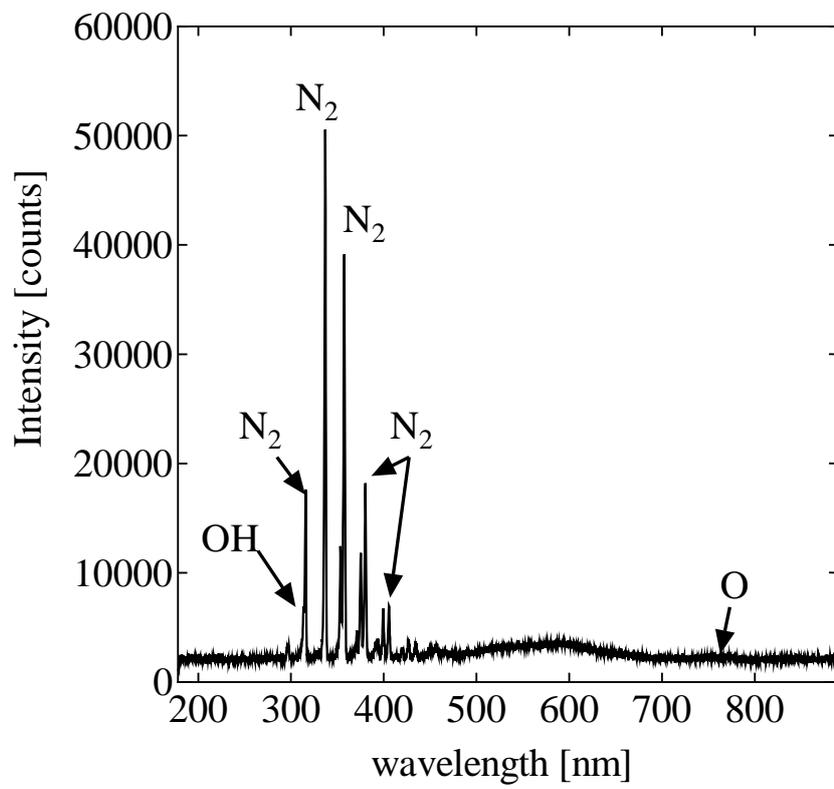
Figure 4.27. Optical Emissions during an SD Treatment.

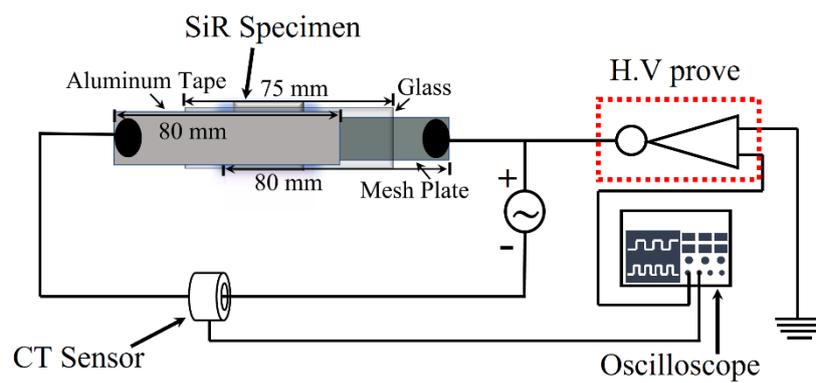
Figure 5.2. Schematic Diagram of an Experimental Setup for Generating SD.

An SD electrode consists of a quartz glass plate, an aluminium (Al) tape and a 150-mesh-SUS wire mesh plate. The length and the width of the quartz glass plate are 75 mm and 25 mm, respectively, and the thickness is 0.5 mm. The 150-mesh plate is 80 mm in length and 15 mm in width. The hole size and thickness are 0.1 mm and 0.06 mm, respectively. The size of the Al tape is 80 mm in length and 20 mm in width and the thickness is 0.1 mm. A quartz glass plate is sandwiched between the Al tape and the 150-mesh-SUS wire mesh plate. The overlapped region of the Al tape and the 150-mesh-SUS wire mesh plate on the quartz glass is 15 mm × 30 mm in which SD is formed. Figure 5.2 shows a schematic diagram of an experimental setup for generating SD. An H.V. probe and a CT sensor were used to measure the applied voltage and the discharge current, respectively. The 150-mesh-SUS wire mesh plate was connected to an H.V. source while the Al tape was earthed. To record waveform data, a digital oscilloscope with a sampling frequency of 1.25 GHz was used. SD treatments were performed under certain conditions in Table 5.1. Before each SD treatment, the artificially degraded SiR surface, which was fabricated following via 5 steps in Section 5.2.1, was cleaned with alcohol, i.e., there is no visible red clay and any silicon oil on the SiR surface. Then, the artificially degraded SiR surface was faced with a 150-mesh-SUS wire mesh plate in the SD treatment. After each SD treatment, the contact angle of the artificially degraded SiR surface was measured every 10 min until it was restored to an original contact angle.

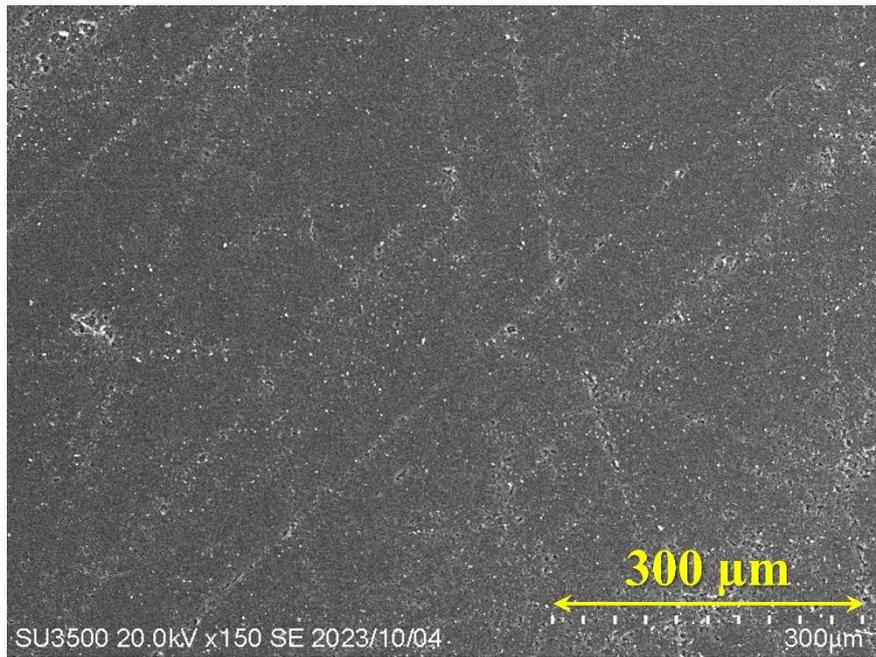
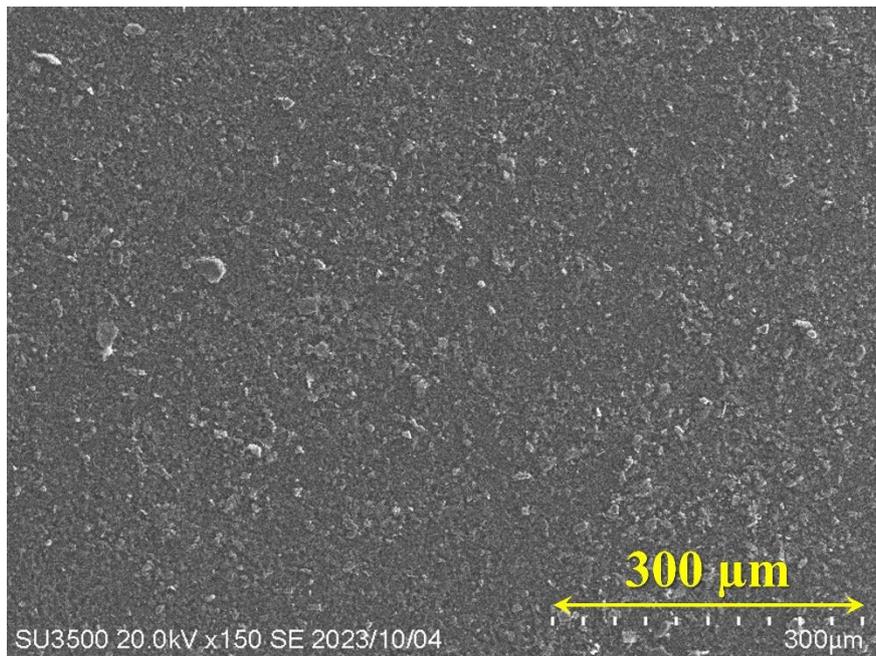
Figure 5.3. SEM Images Measured on Artificially Degraded SiR Surfaces Made by (a) 1-cycle Test and (b) 2-cycle Test.

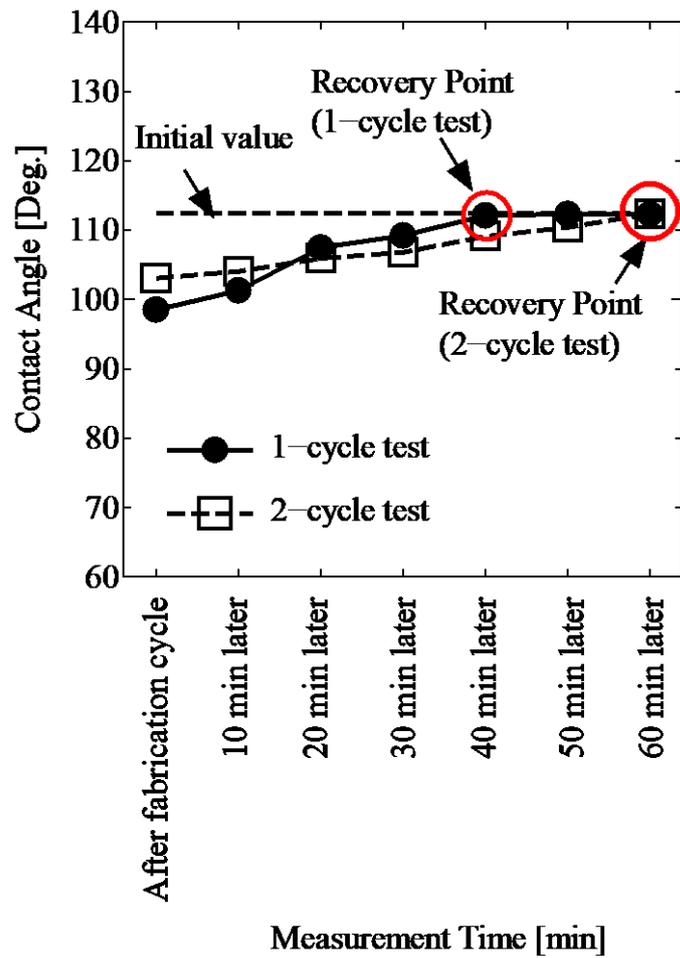
Figure 5.4. Variations in Contact Angle Measured on Artificially Degraded SiR Surface Made by a 1-cycle Test and a 2-cycle Test.

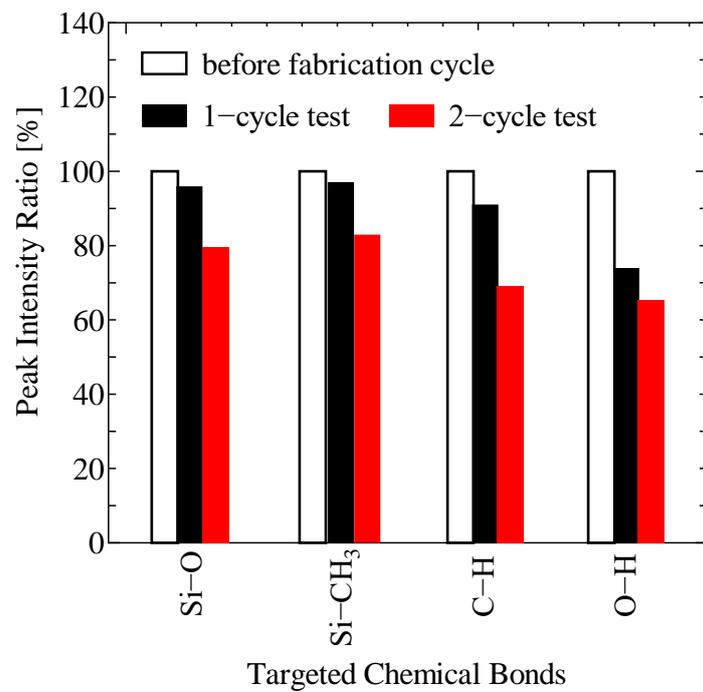
Figure 5.5. Peak Intensity Ratios on SiR Surfaces before Making Degraded Surface and Artificially Degraded SiR Surfaces Made by a 1-cycle Test and a 2-cycle Test.

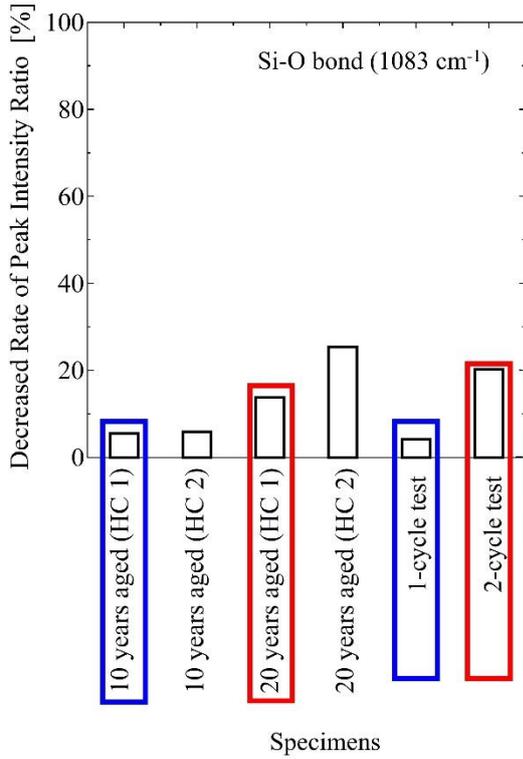
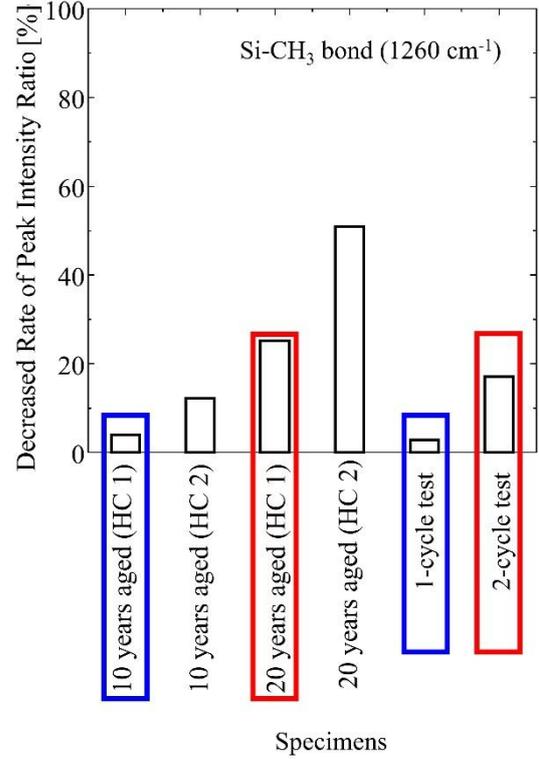
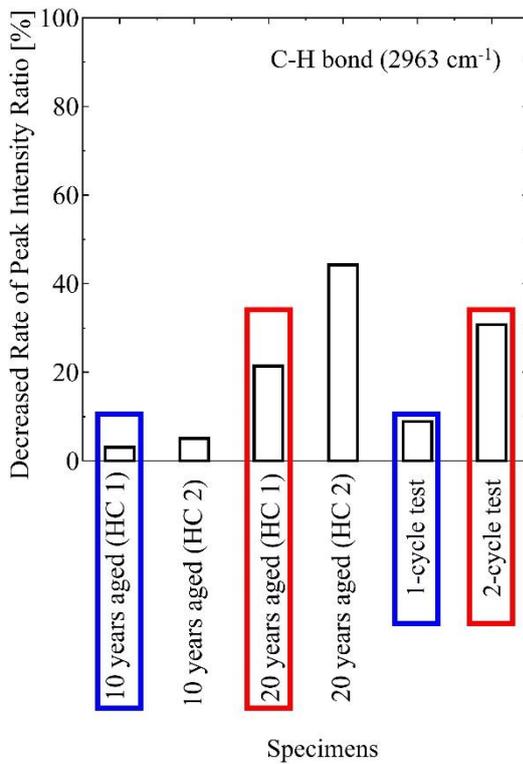
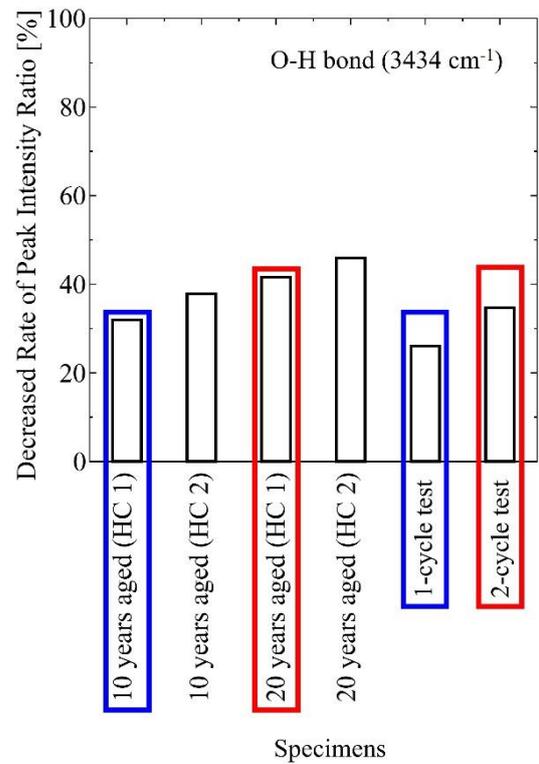
In addition, the decreasing rates of the peak intensity ratios on the aged SiR surfaces and artificially degraded SiR surfaces were compared. Figures 5.6(a), 5.6(b), 5.6(c) and 5.6(d) shows the decreasing rates of Si-O, Si-CH₃, C-H, and O-H bonds, respectively. The comparison of decreasing rates of the peak intensity ratios between the artificially degraded SiR surface made by a 1-cycle test and the 10-year-aged SiR surface on the hydrophobicity class 1 (HC1) portion is represented by a blue rectangular bar. The decreasing rates of the artificially degraded SiR surface made by a 1-cycle test are similar to those of the 10-year-aged SiR surface on the HC 1 portion. Also, a red rectangular bar represents the comparison between the artificially degraded SiR surface made by a 2-cycle test and the 20-year-aged SiR surface on the HC 1 portion. The decreasing rates of the artificially degraded SiR surface made by a 2-cycle test are similar to those of the 20-year-aged SiR surface on the HC 1 portion.

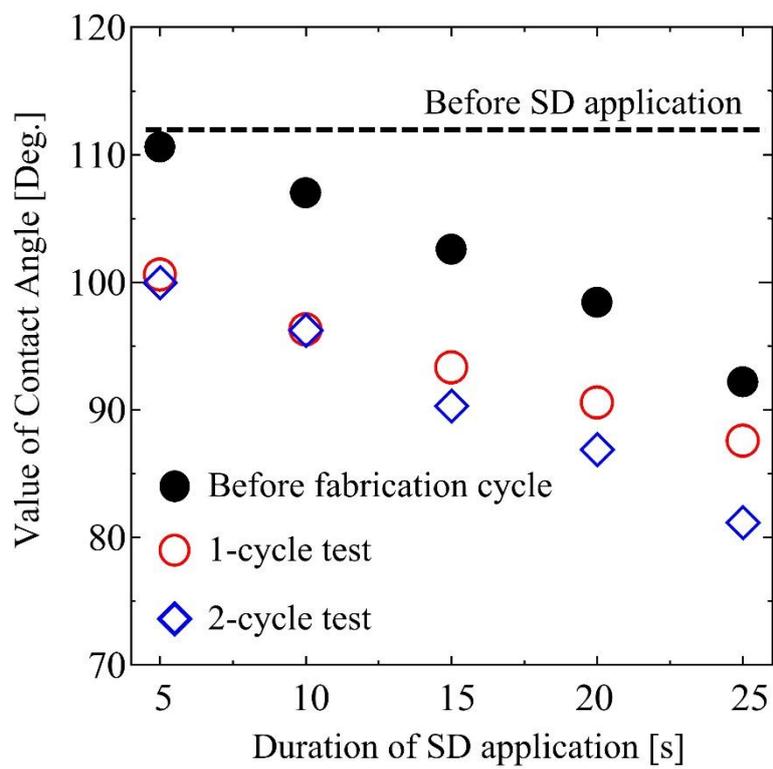
Figure 5.8. Temporal Variation of Contact Angles on SiR Surfaces Before Fabrication Cycle, 1-cycle Test and 2-cycle Test after SD Treatment.

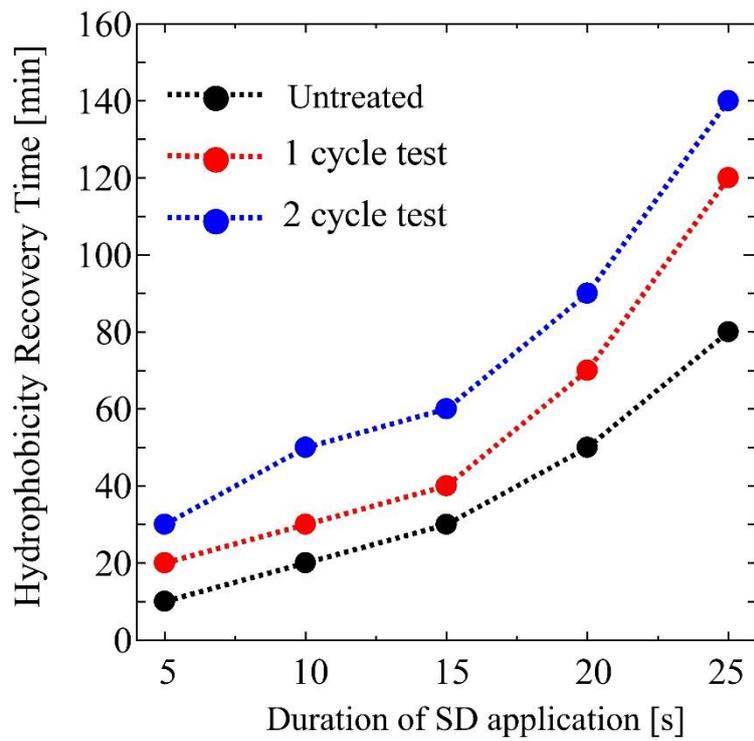
Figure 5.12. Hydrophobicity Recovery Times on SiR Surface before Making Degraded Surface and Artificially Degraded SiR Surfaces Made by a 1-cycle Test and a 2-cycle Test.
